ENGINEERING EVALUATION COVERSHEET

Number: EVAL-DE-2012-0316

Title: X-700 Roof Structural Integrity Assessment

Project: **Structural Integrity Assessment** Engineering Evaluation No.: **EVAL-DE-2012-0316 Rev.3**

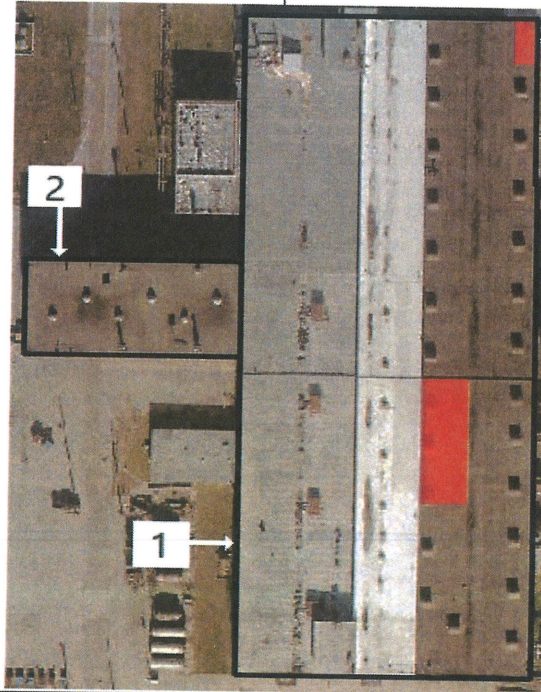
*NOTE: Access to the roof is restricted between columns E4/D4 through E7/D7 and F13/EF13 through F14/EF14.

The **X-700** roof is structurally adequate for Routine Maintenance Access to the areas identified above in the roof sketch for six employees (as defined on page 1 of this FBP Building Roof Assessment) on each of the two roof sections.

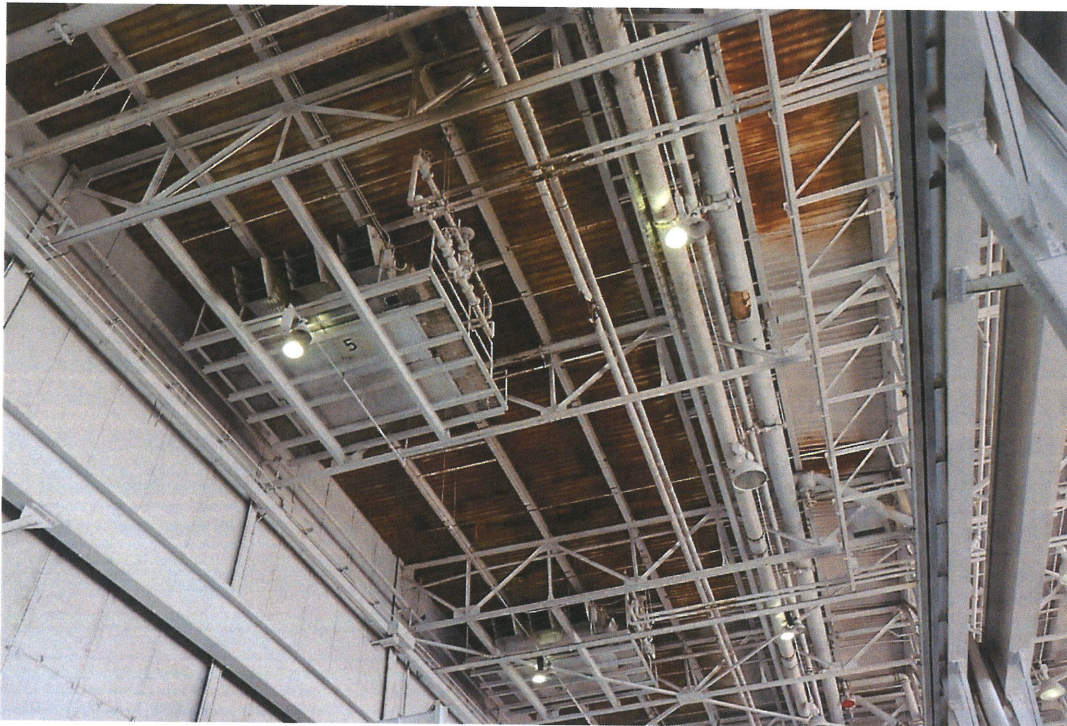
Corrosion in large area of roof between columns D4/D7 and E4/E7

The previous revision's restriction placed on the highbay encompassing columns D4/D7 and E4/E7 is still in effect. Additionally, Engineering found corrosion in the metal decking, not documented in previous revisions, on the Northwest corner of the roof. Engineering is restricting access to the roof in this area encompassing columns F13/F14 and EF13/EF14. If access is needed in these areas, contact Engineering for further analysis. These restricted areas are illustrated in Attachment A.

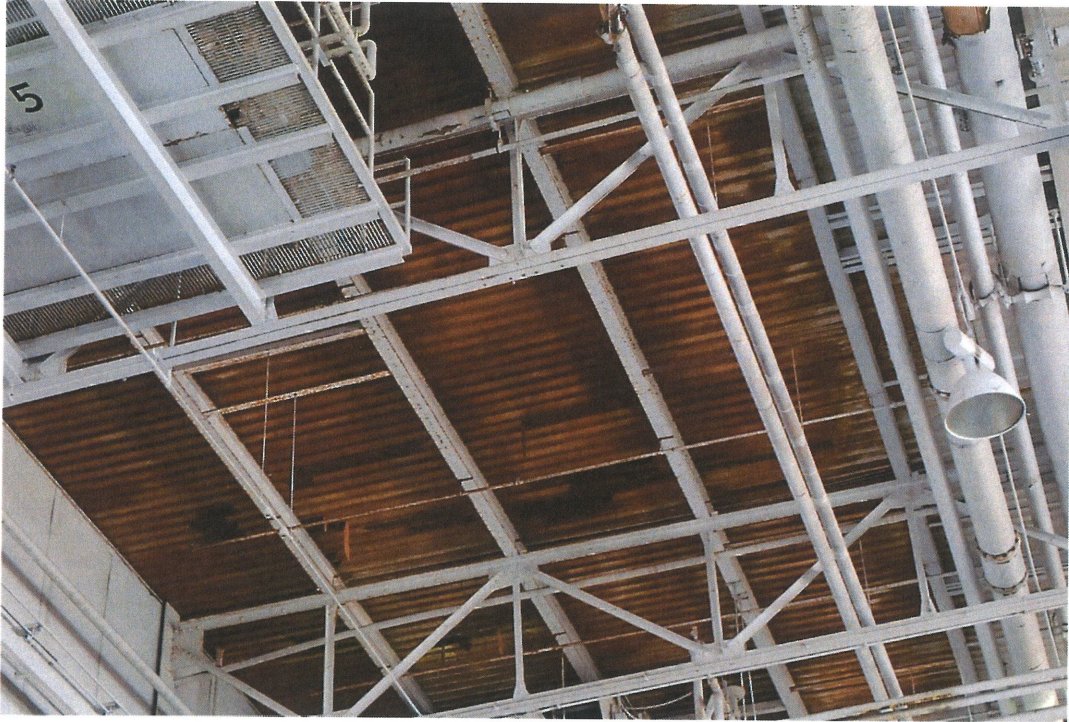
Closer look at corrosion

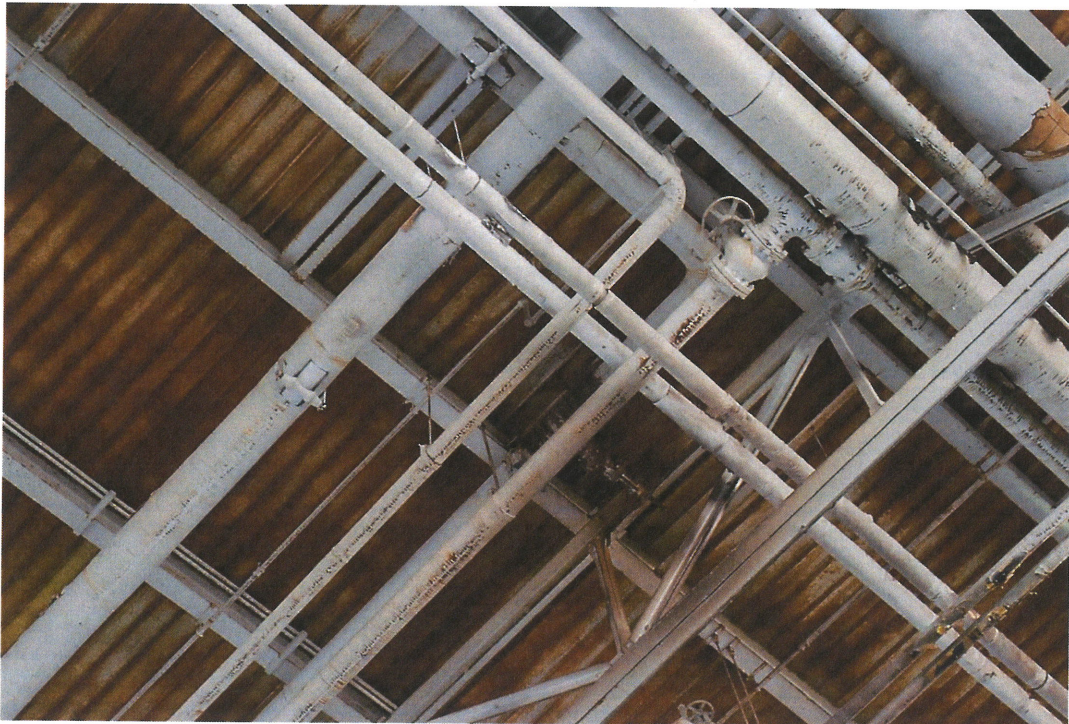
Close up of corrosion

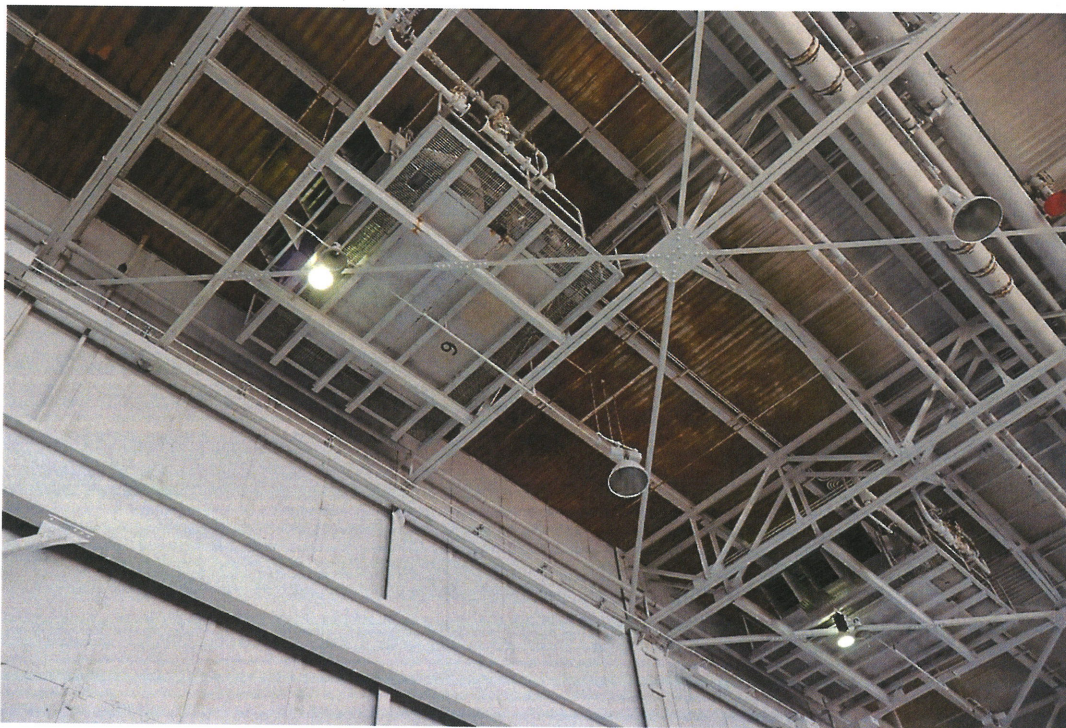
Corrosion between columns D4/D7 and E4/E7

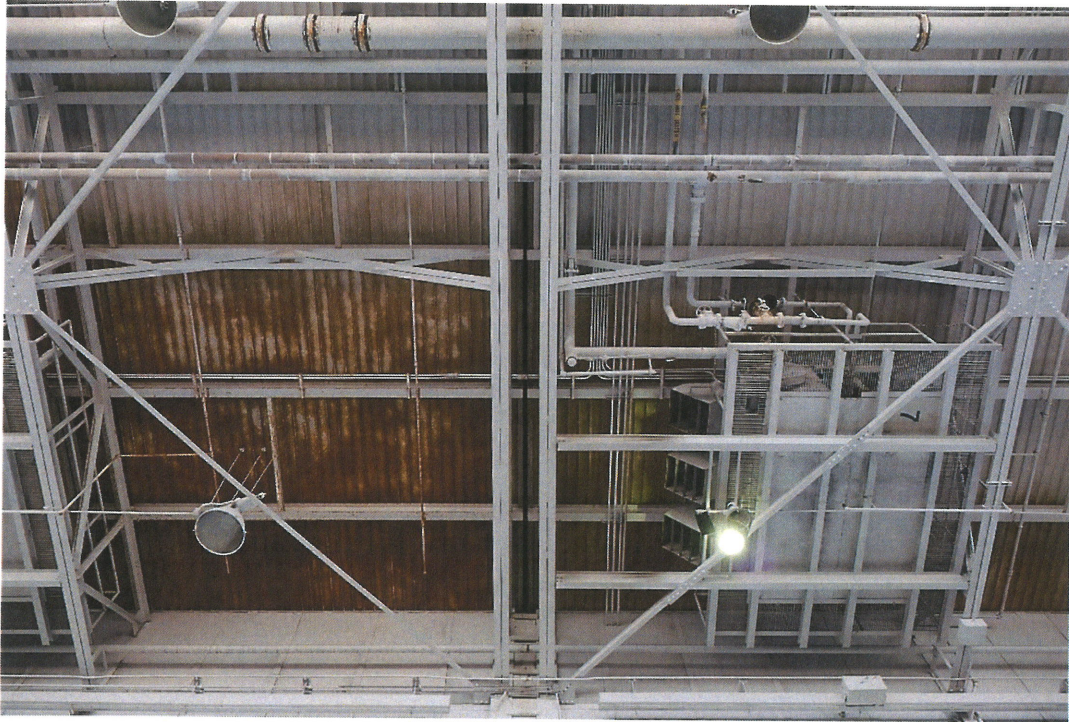
Corrosion between columns D4/D7 and E4/E7

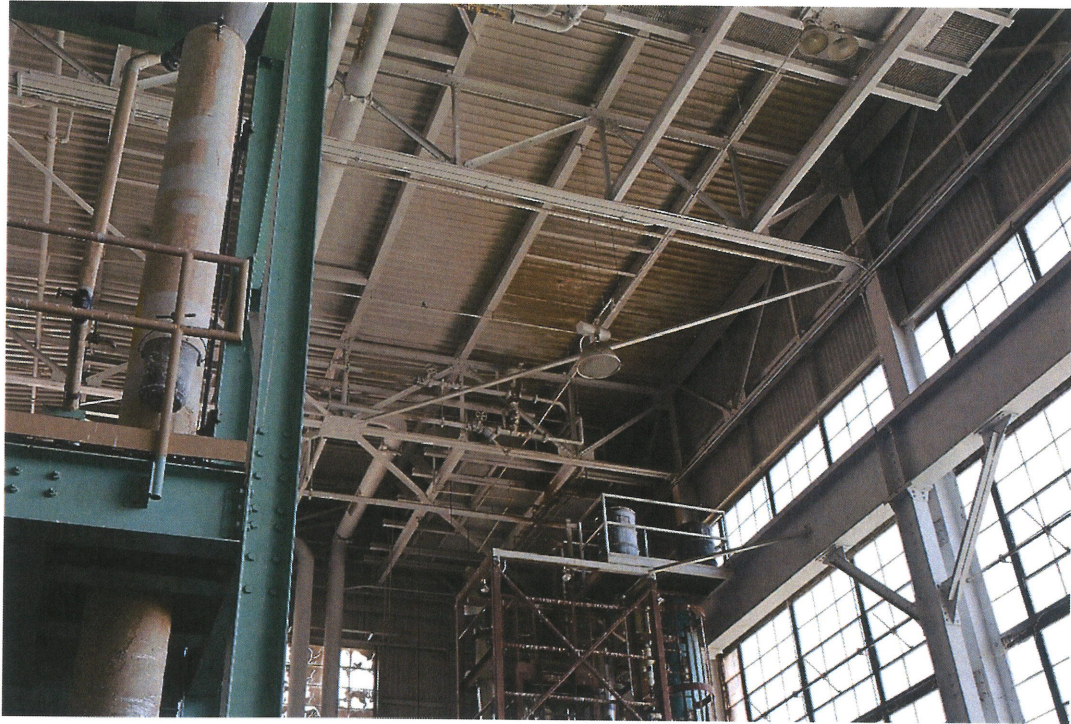
Corrosion on Northeast side of roof between columns EF13/EF14 and F13/F14

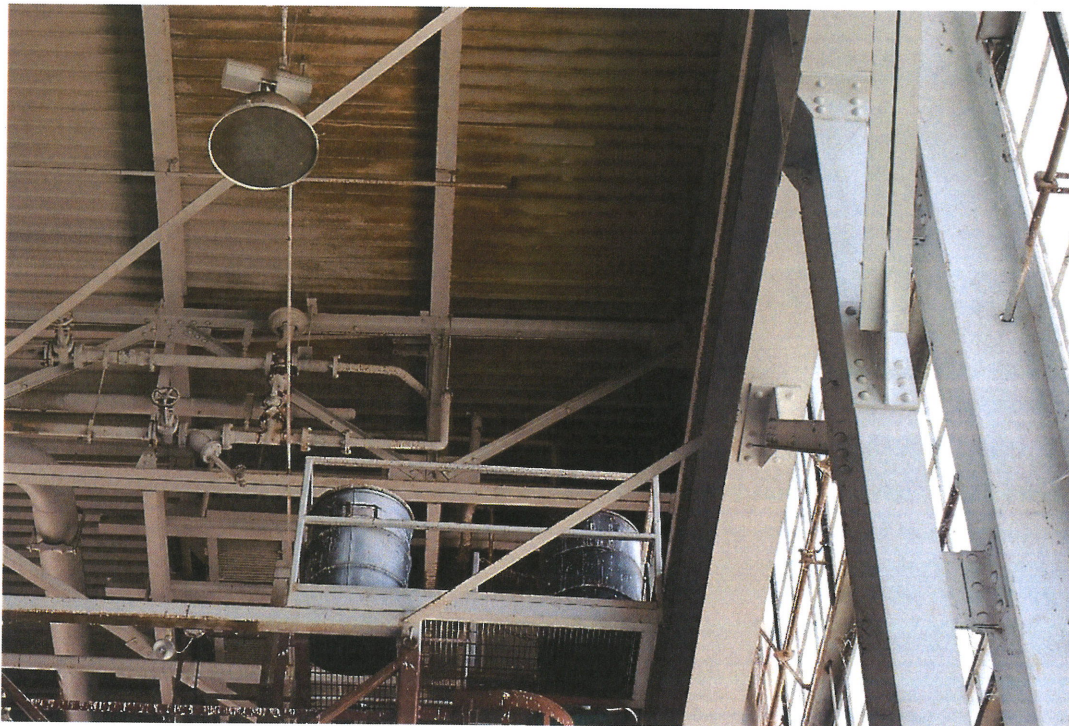
Close view of corrosion

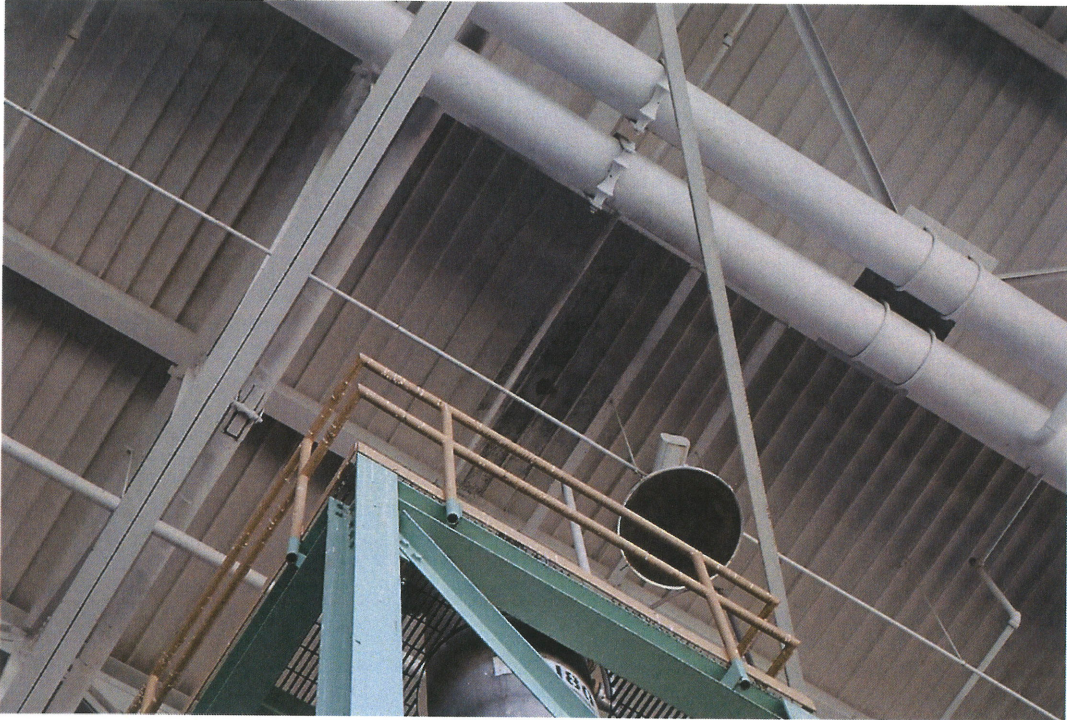
Evidence of some sort of repair near column E12

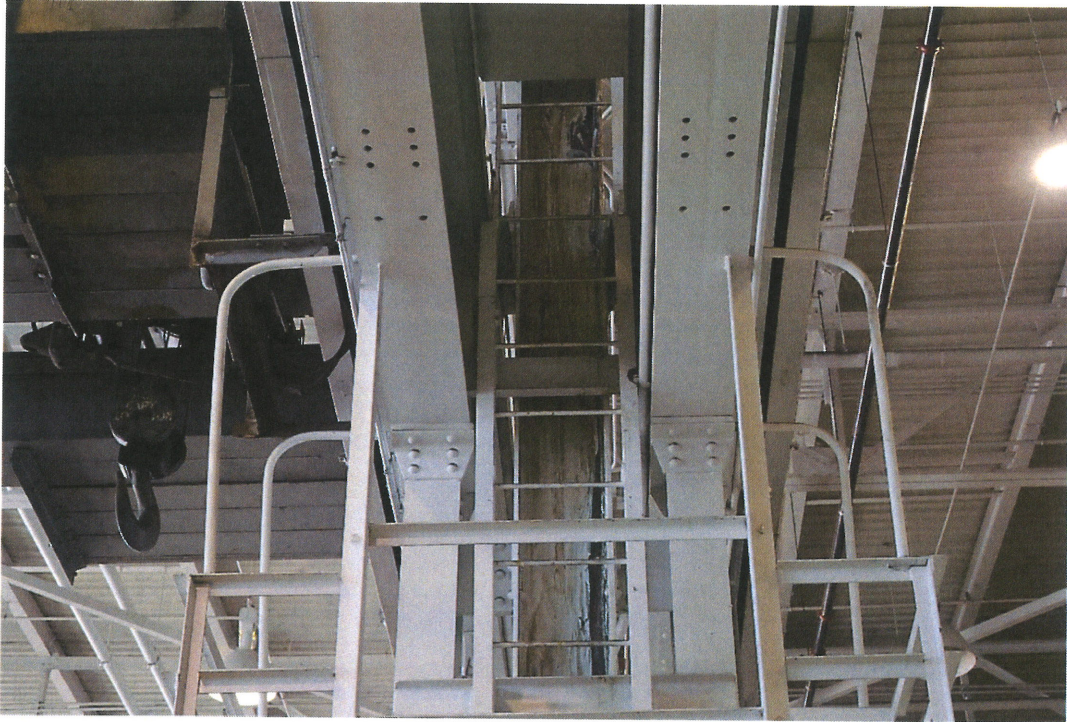
Evidence of water leak on column B3

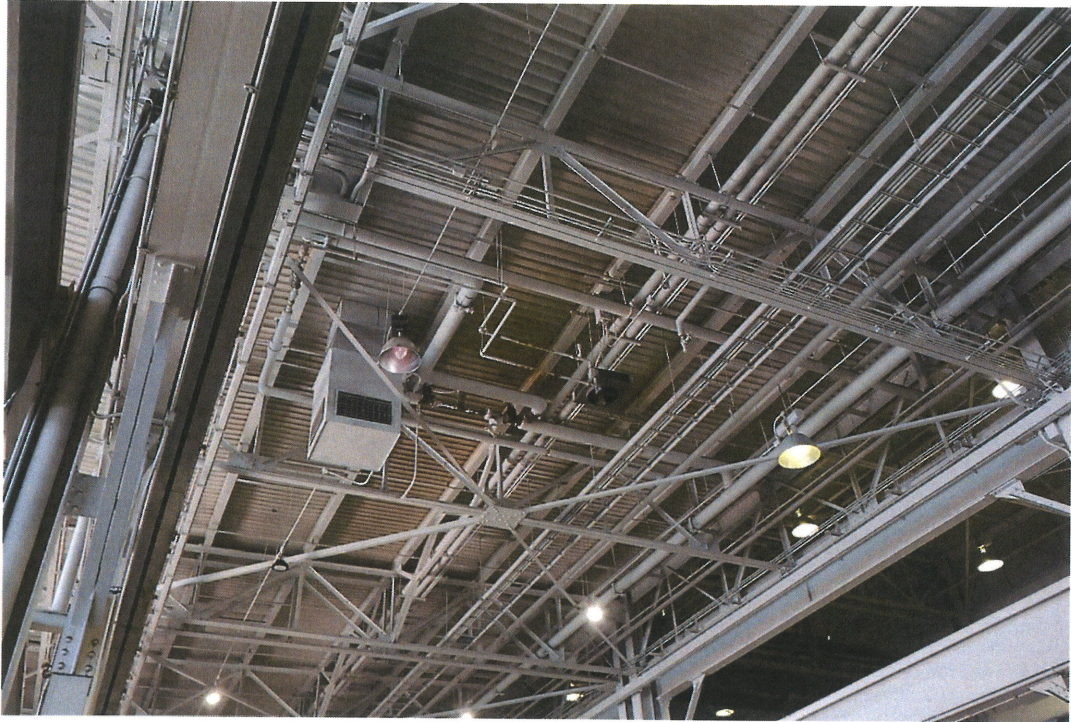
Minor corrosion in roof near column B6

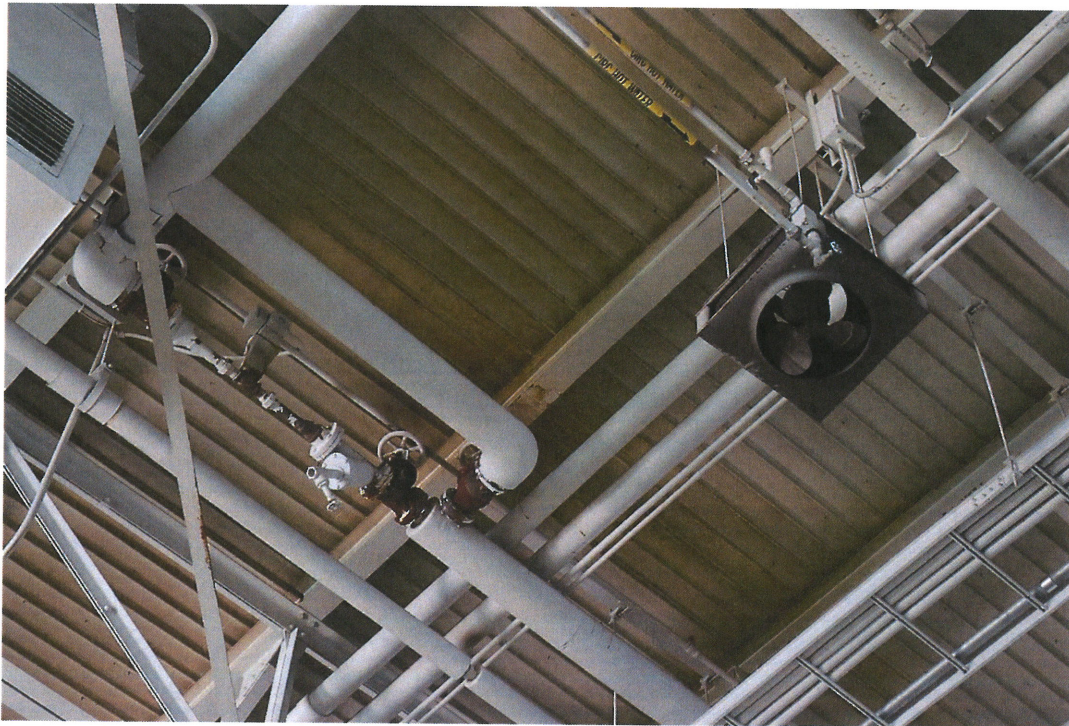
Close up of minor corrosion

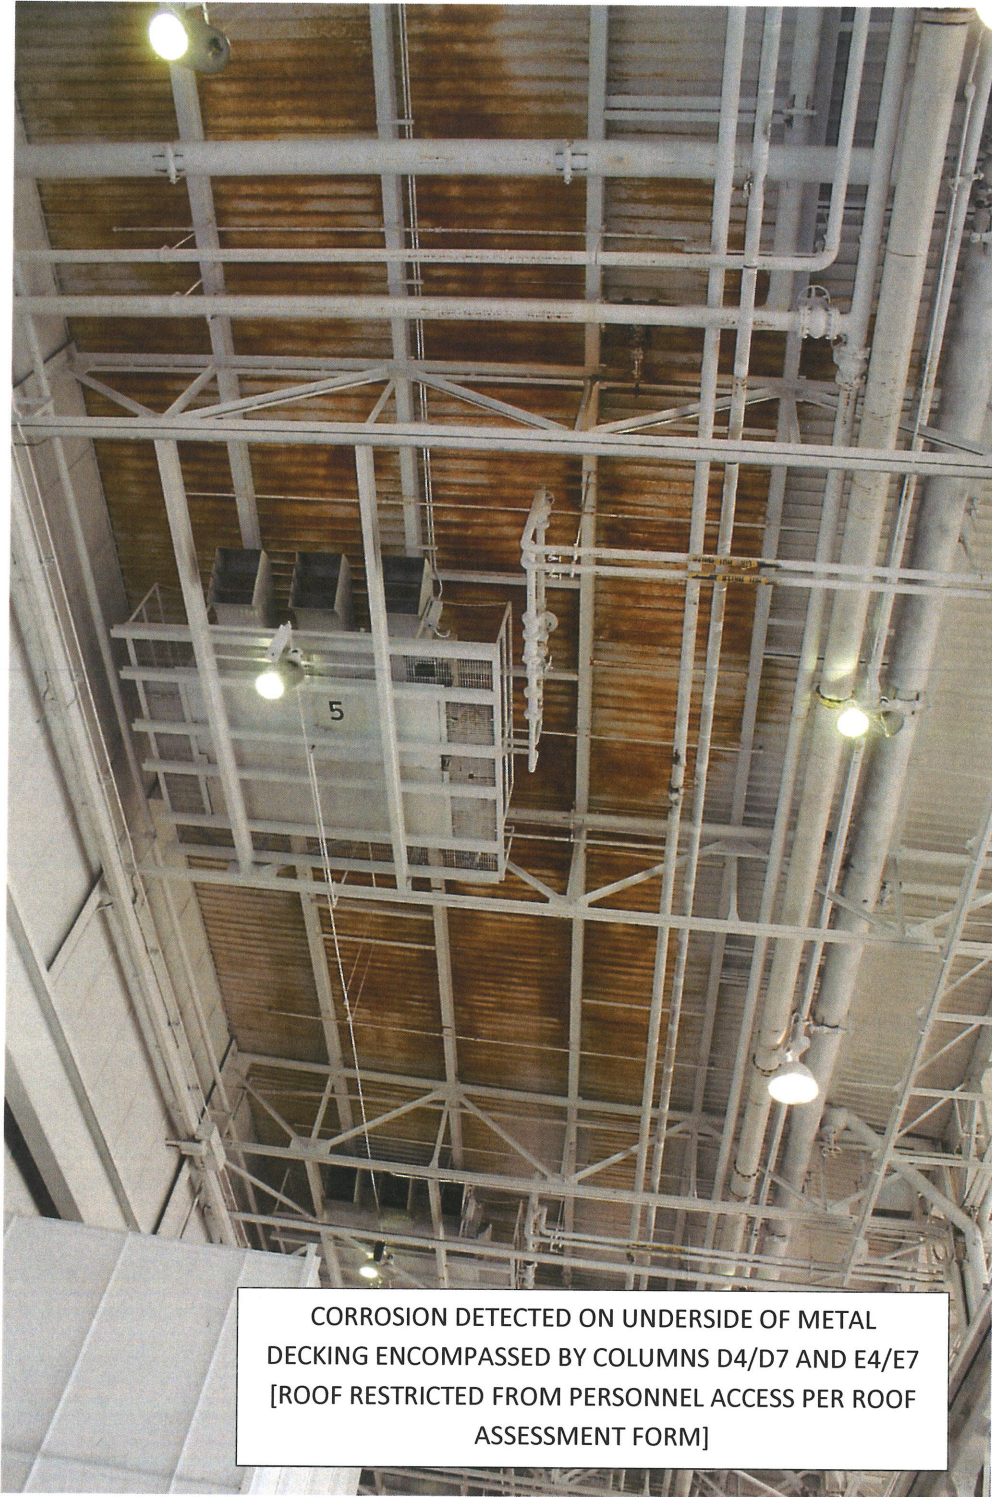
CORROSION DETECTED ON UNDERSIDE OF METAL DECKING ENCOMPASSED BY COLUMNS D4/D7 AND E4/E7 [ROOF RESTRICTED FROM PERSONNEL ACCESS PER ROOF ASSESSMENT FORM]

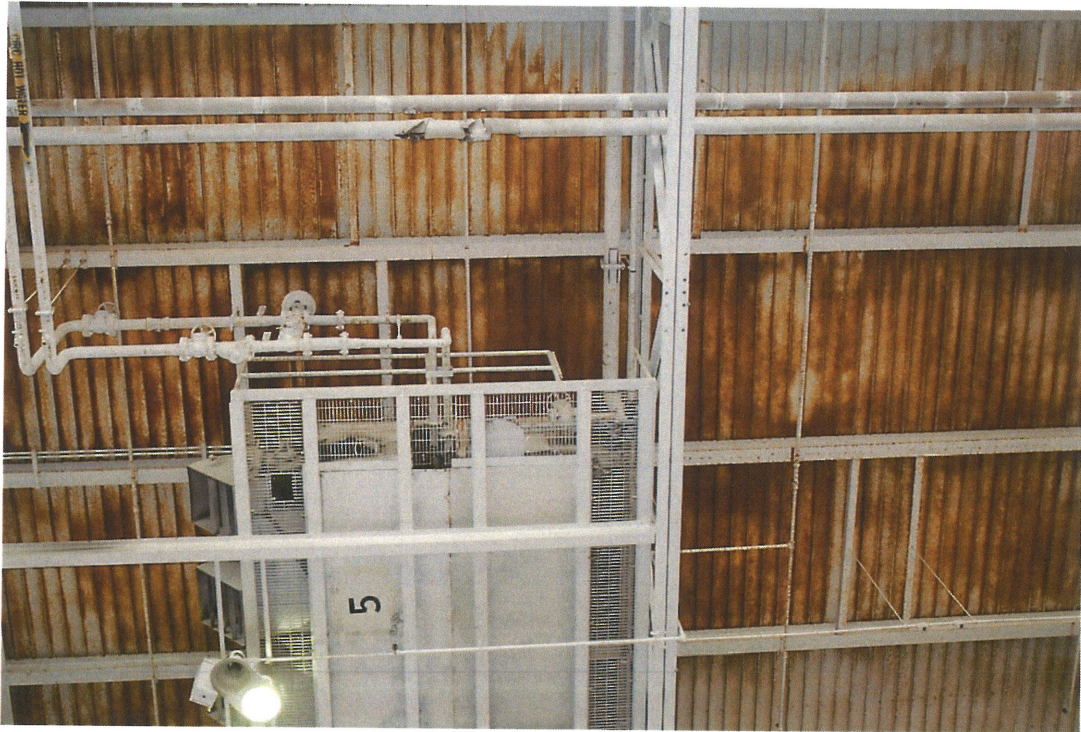
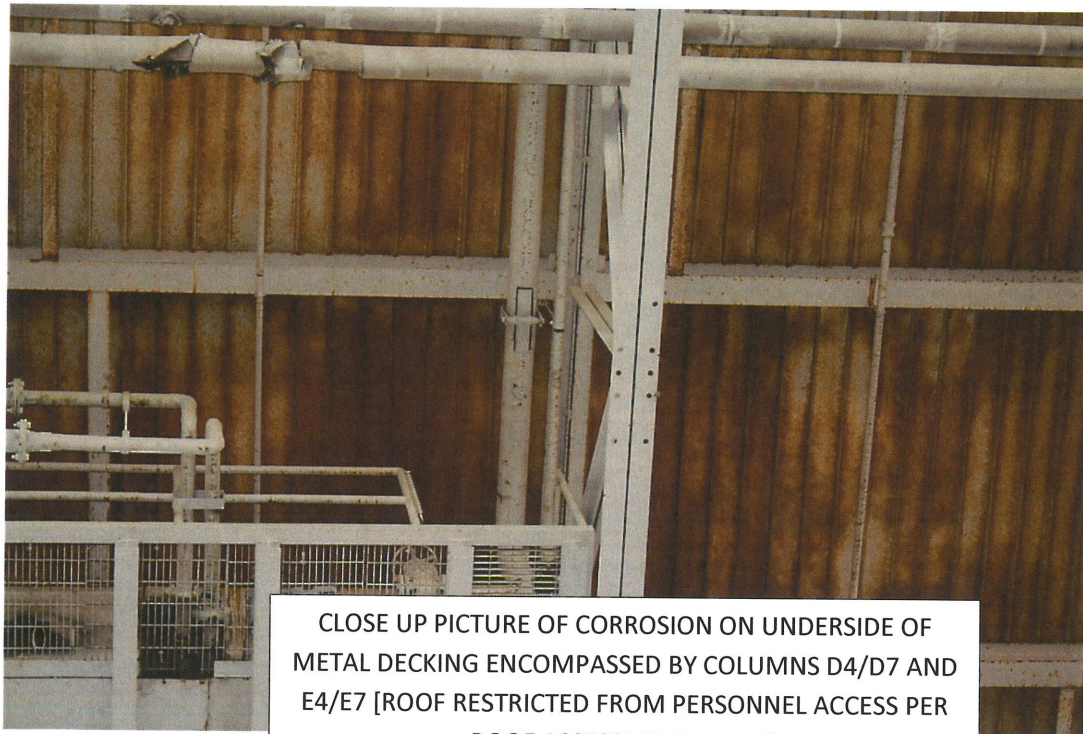
CLOSE UP PICTURE OF CORROSION ON UNDERSIDE OF METAL DECKING ENCOMPASSED BY COLUMNS D4/D7 AND E4/E7 [ROOF RESTRICTED FROM PERSONNEL ACCESS PER ROOF ASSESSMENT FORM]
