## ENGINEERING EVALUATION COVERSHEET

**Number:** EVAL-DE-2020-0009

**Title:** X-720 Roof Inspection

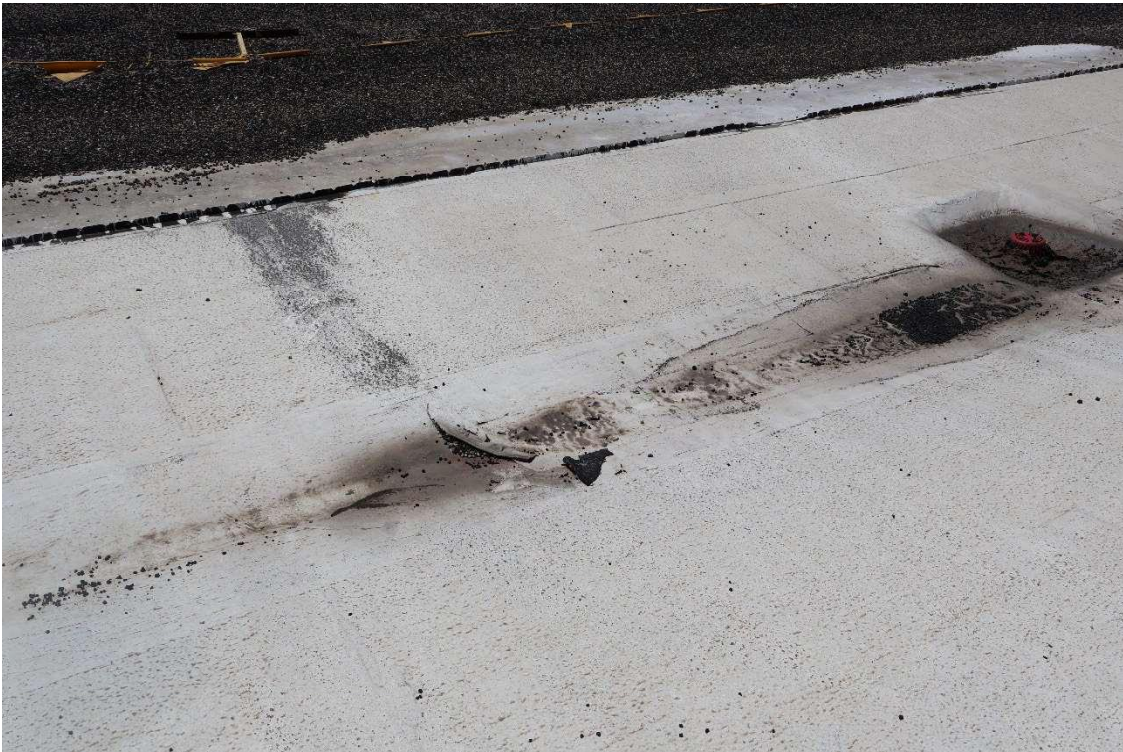
Main Low roof – Damage in the Overlay in the valley

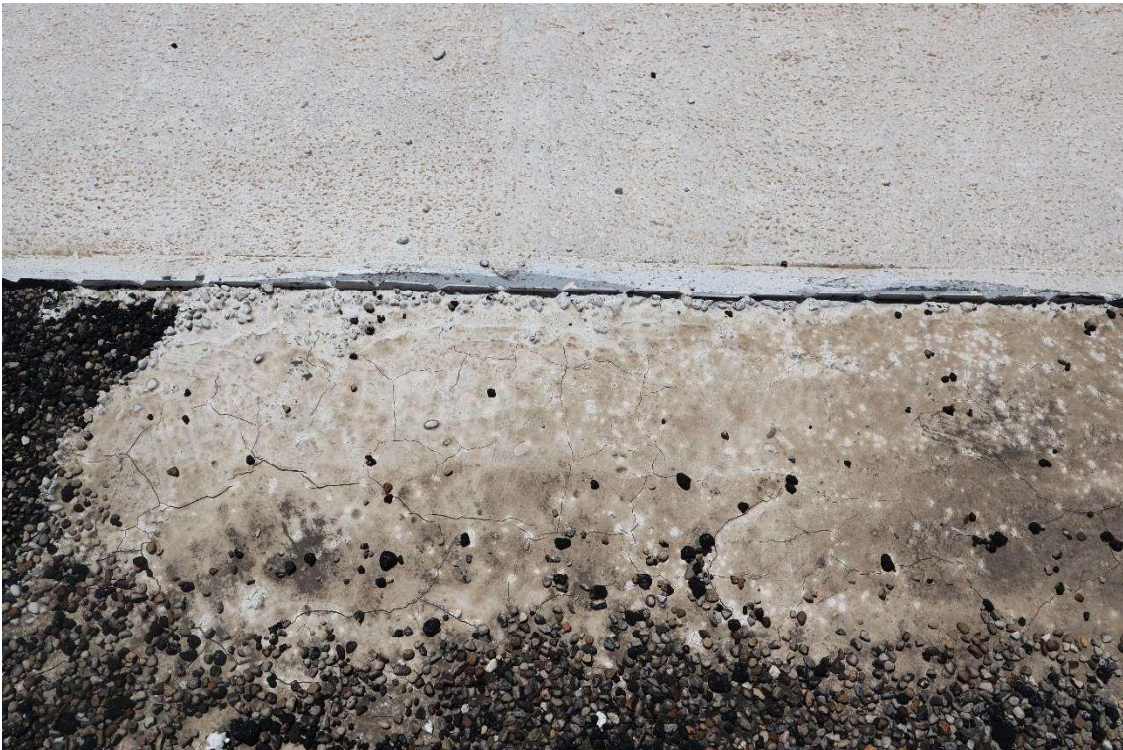
Main Low roof – Small cracks in Overlay

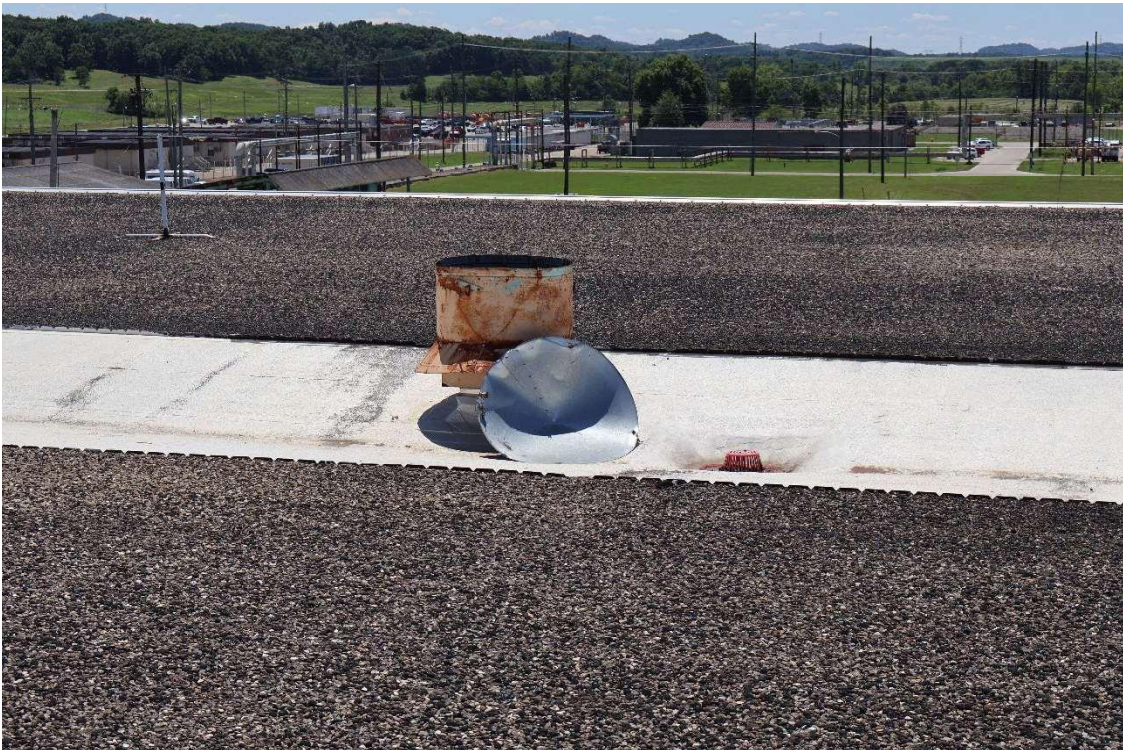
Main High roof – Loose debris broken off from vent

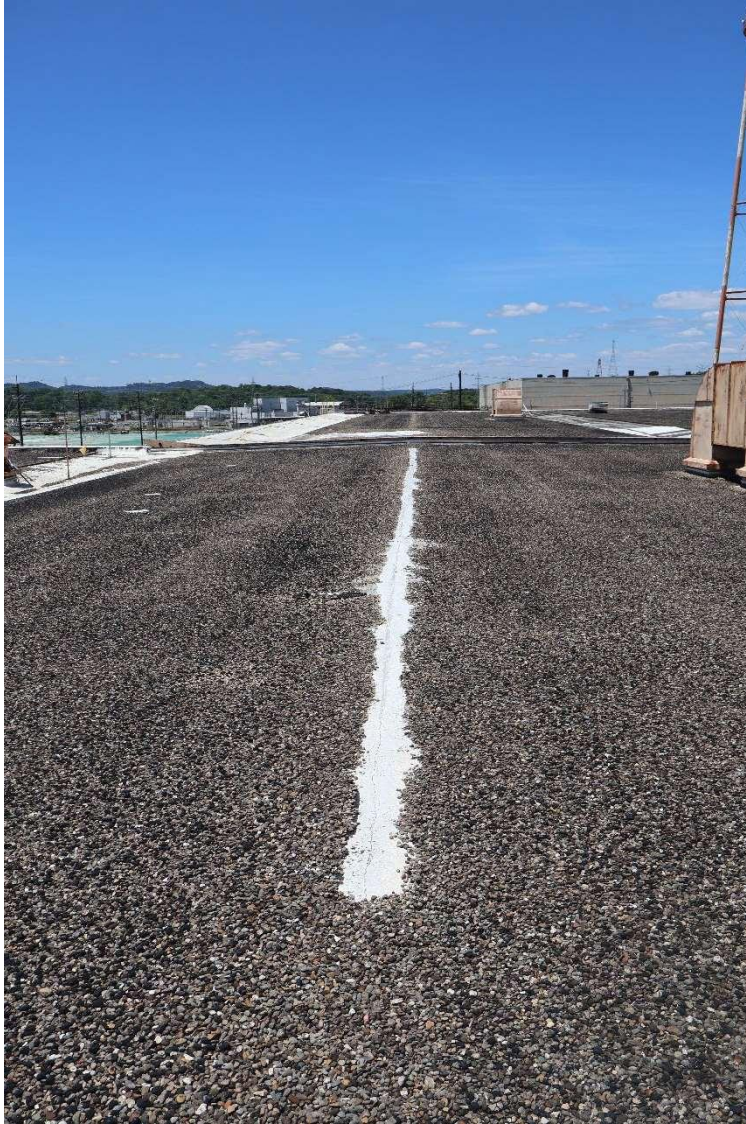
Main High roof – Bare spot in gravel along ridge

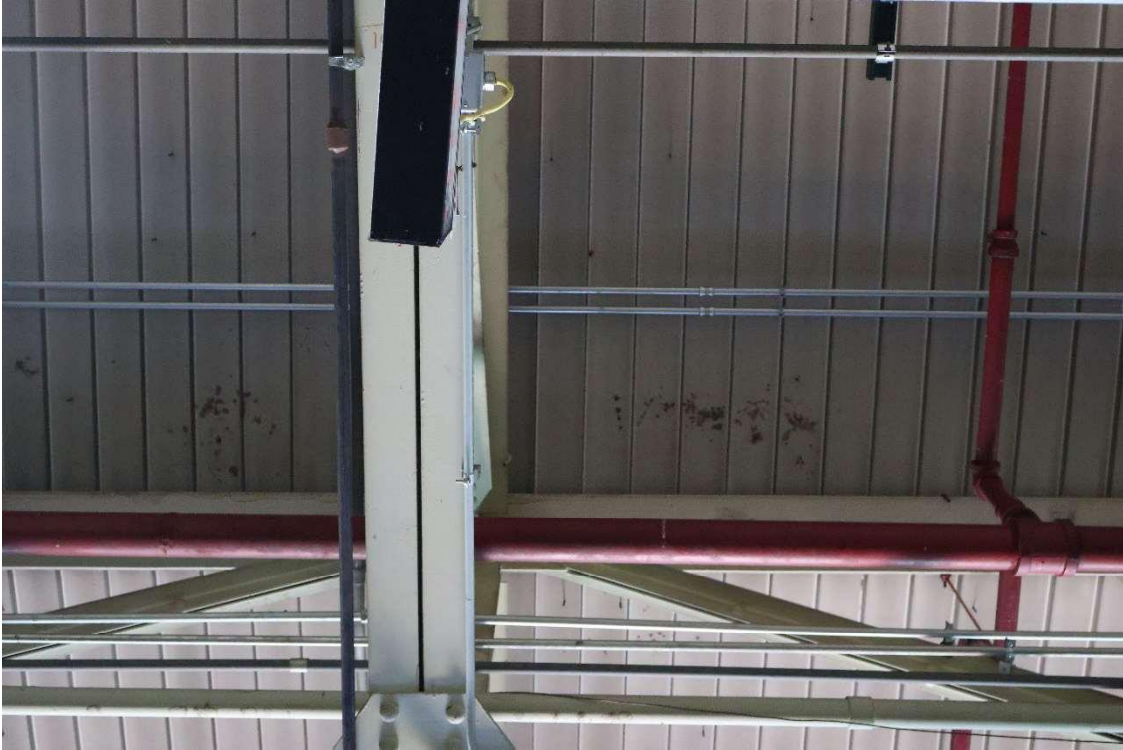
Light surface corrosion near column B14

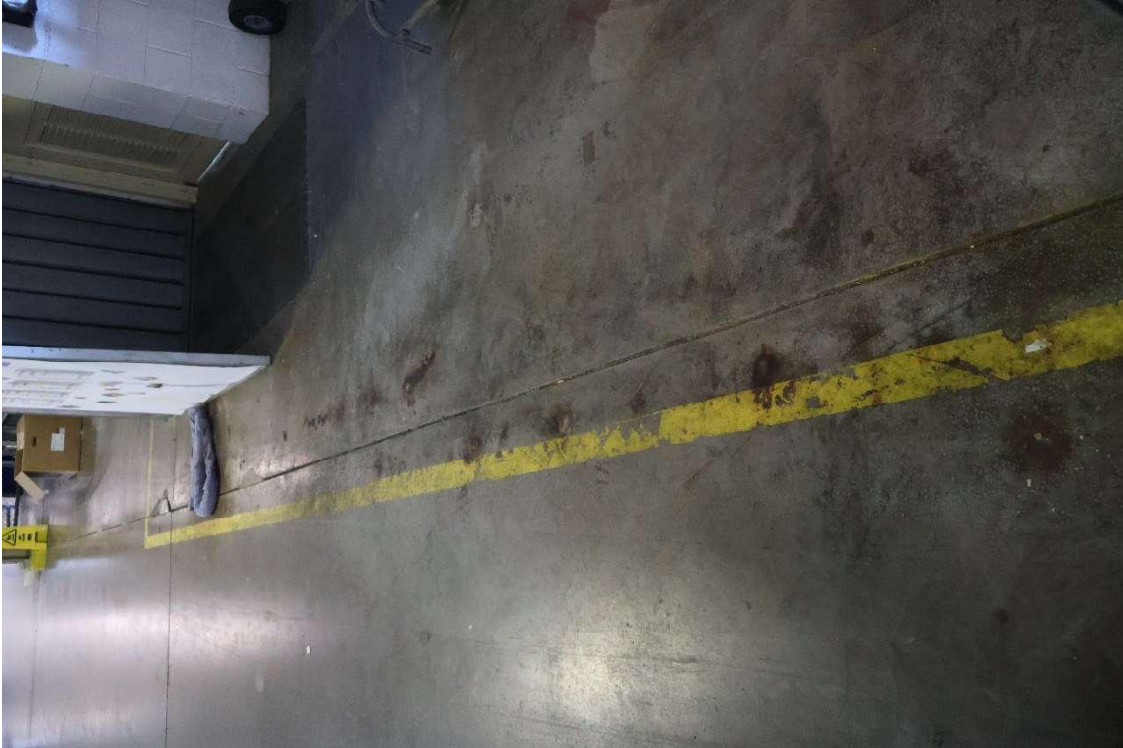
Evidence of leaks near column B13

- Repair roof leaks in multiple locations. The locations with roof leaks are found near columns B13, D15, B8, B10, E4, K2 and K17.
- Remove all vegetation growing on the roof.

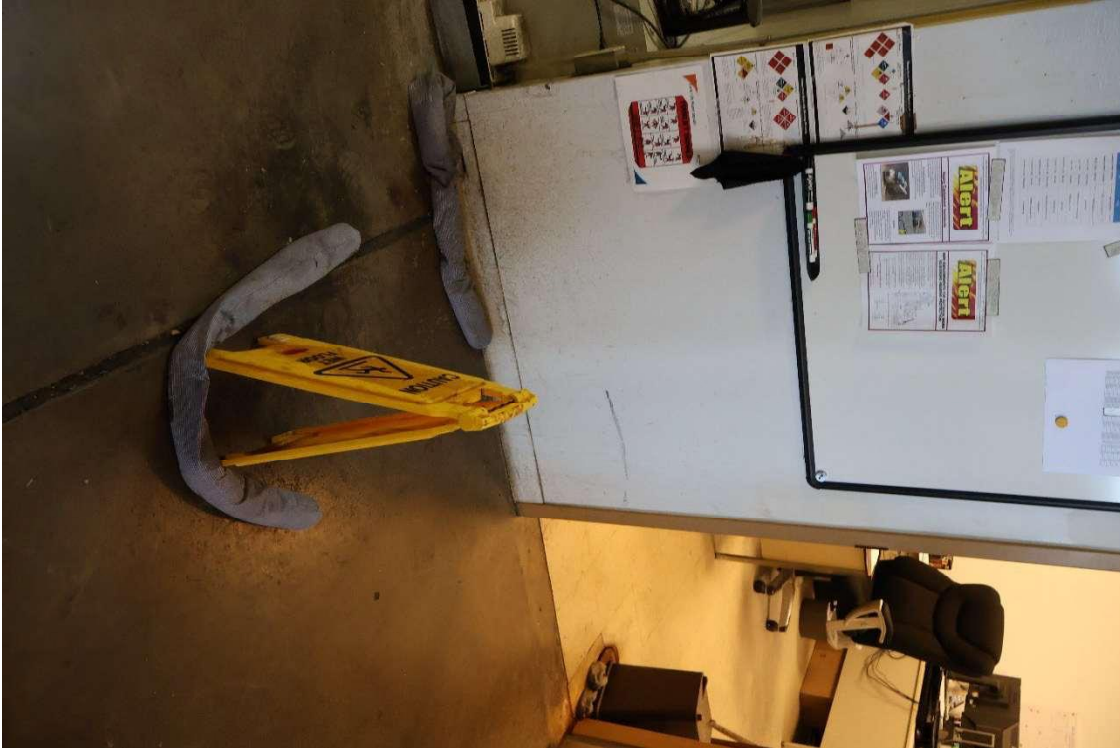
Leak near column C14

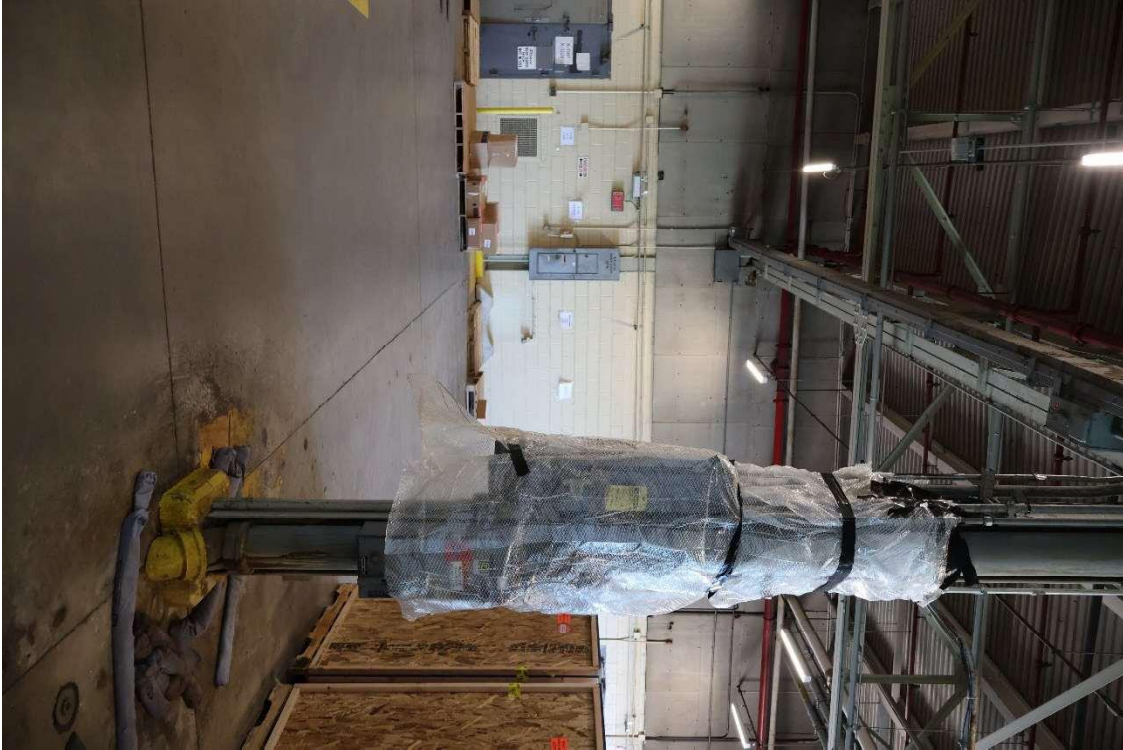
Water damage at column B15

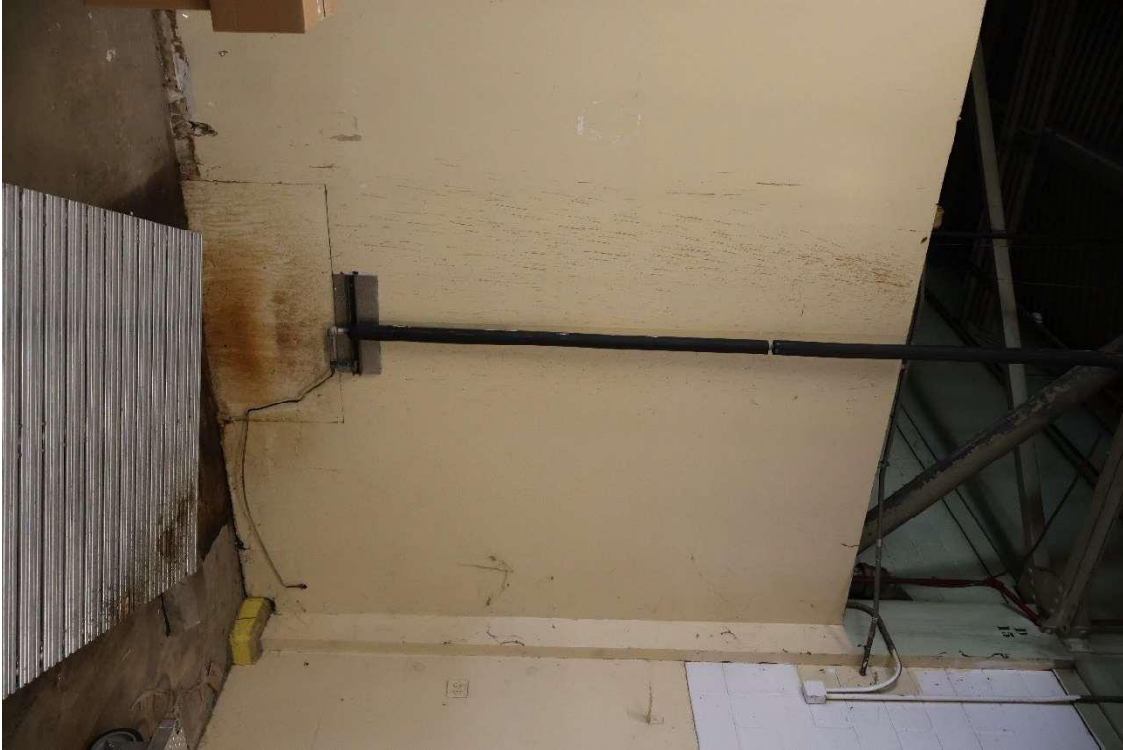
Leak at column D15

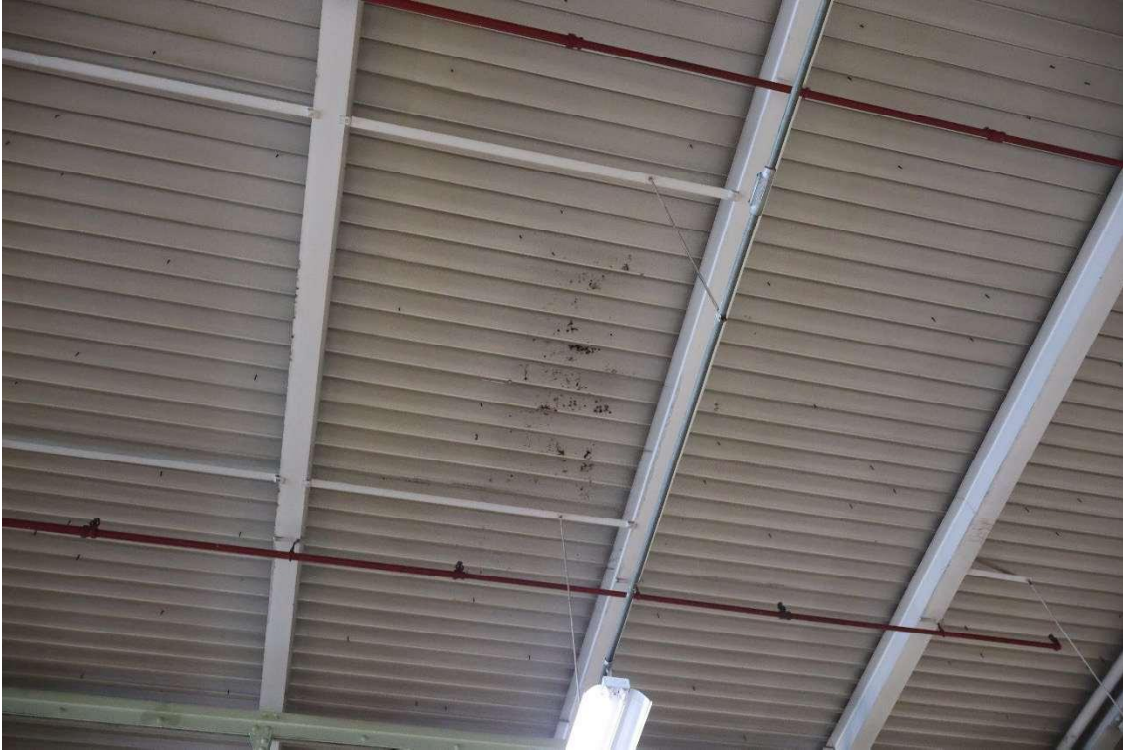
Minor surface corrosion in Respirator Facility

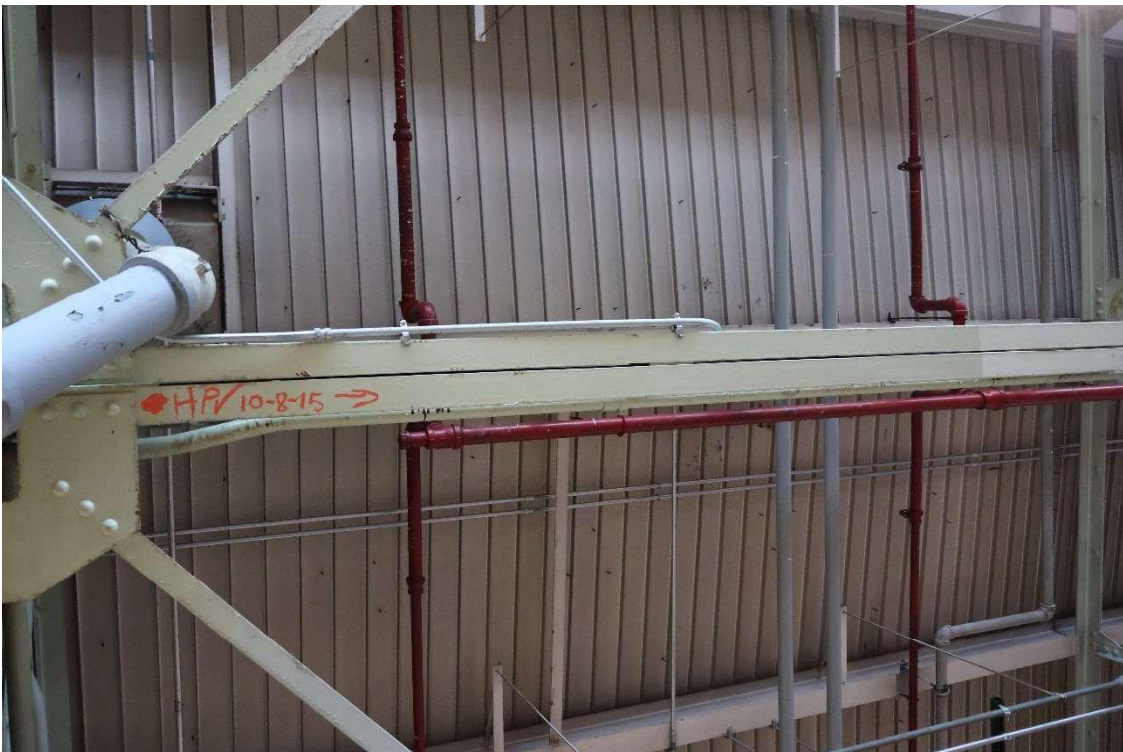
At column B10 where there is a leak

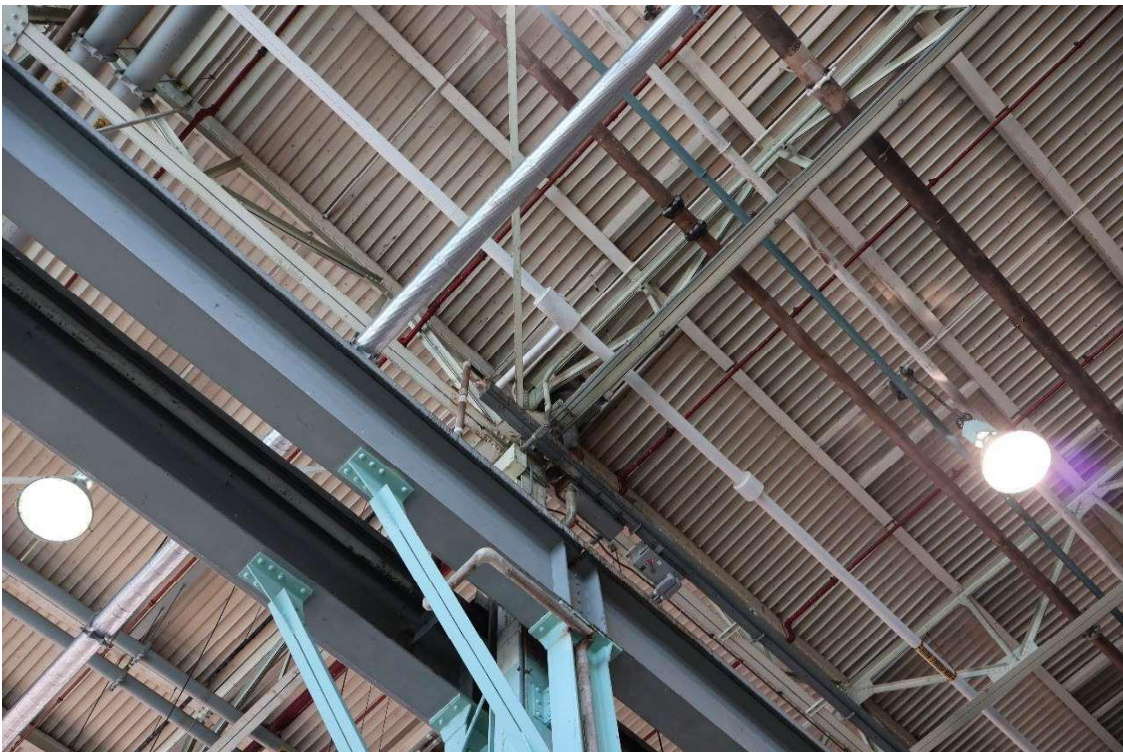
Leak identified near column K2

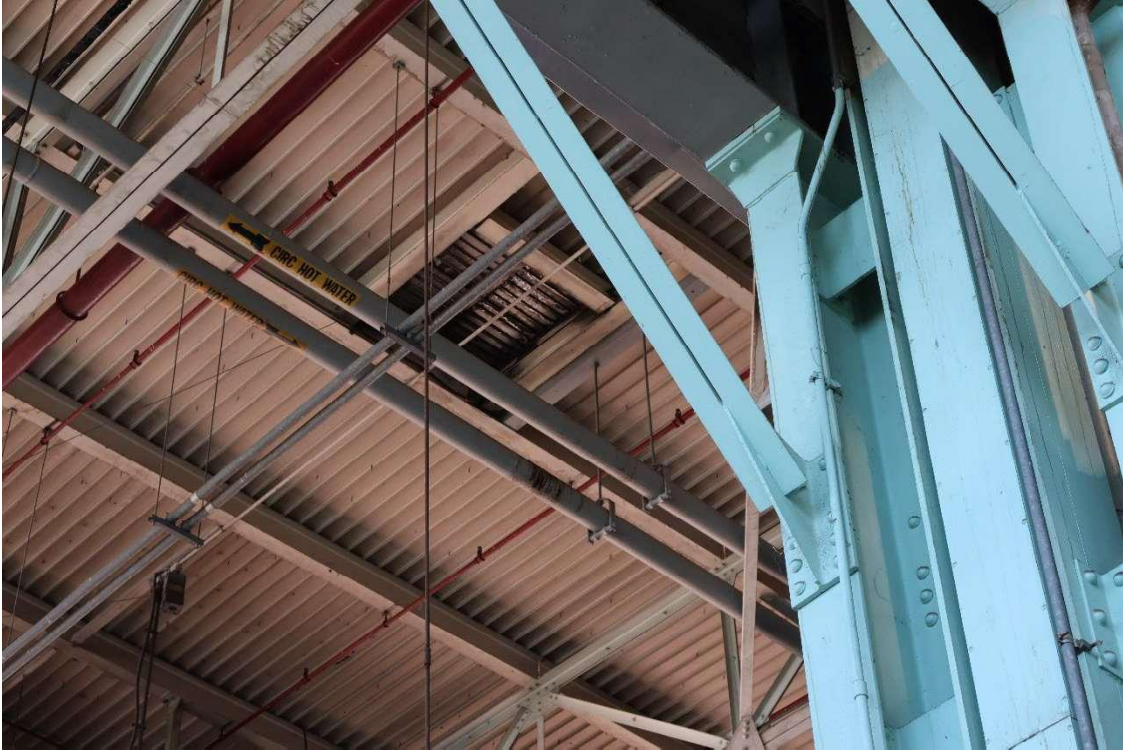
Leak stains on pipes near column K2

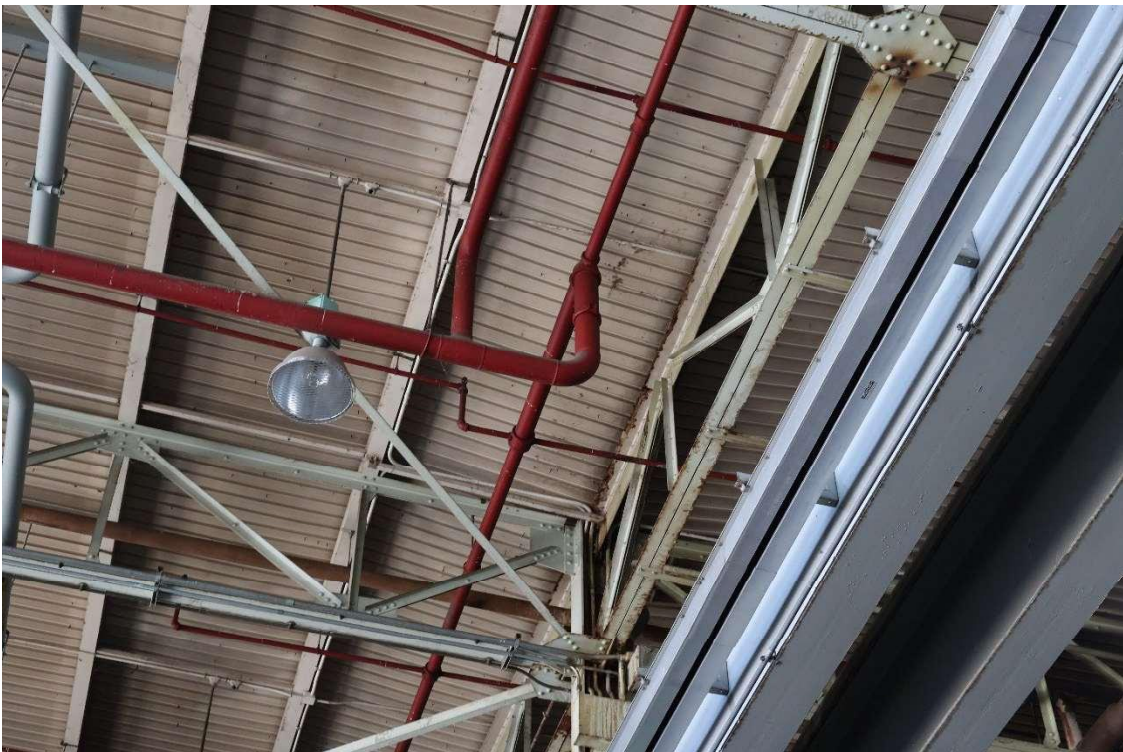
Minor corrosion on beam near K9

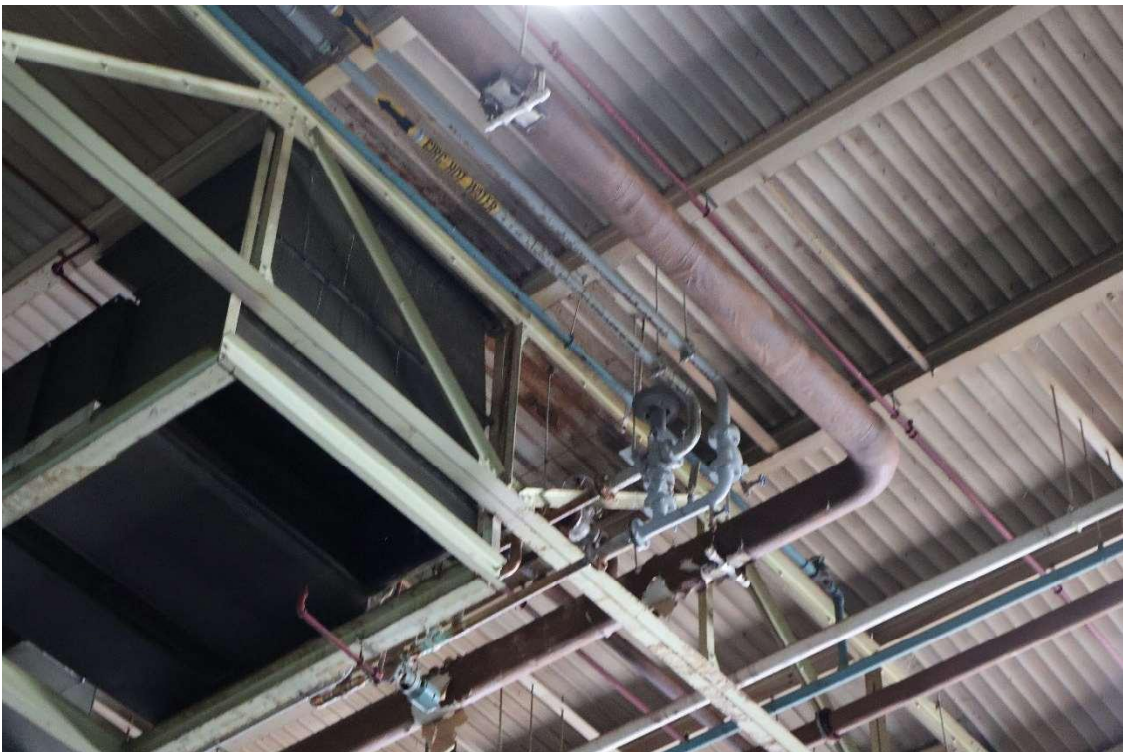
Corrosion visible standing near column J14

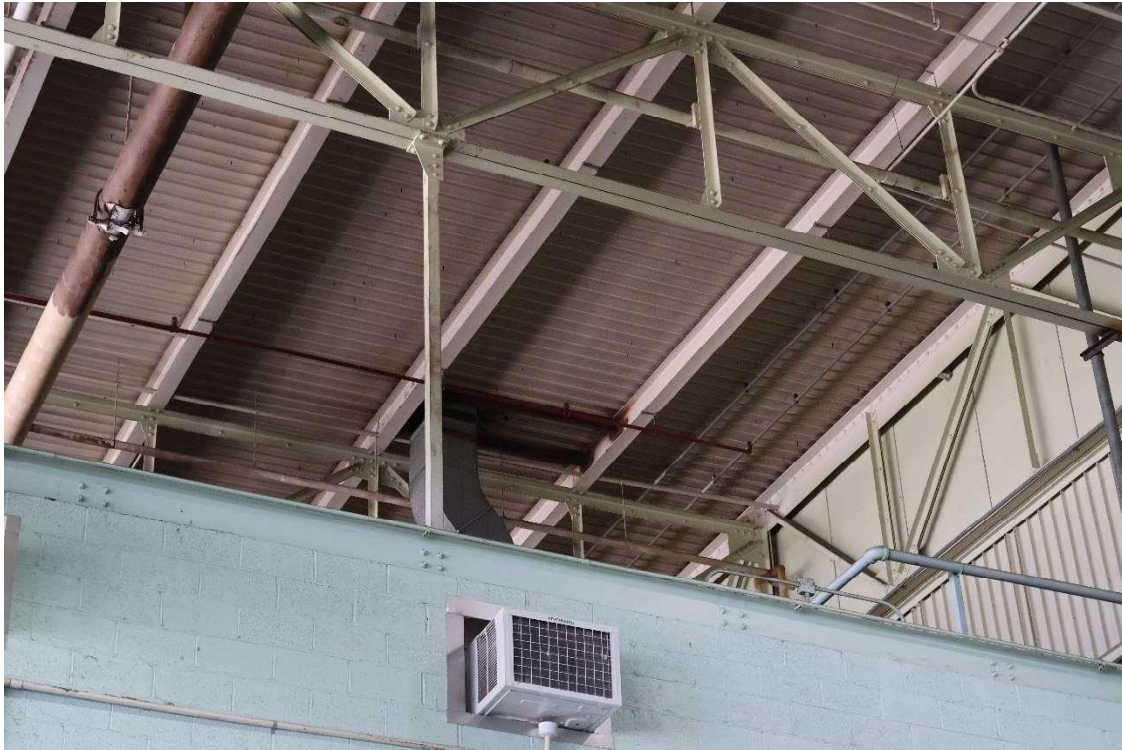
Corroded steel in cross members causing steel beam to corrode, seen standing near column J14

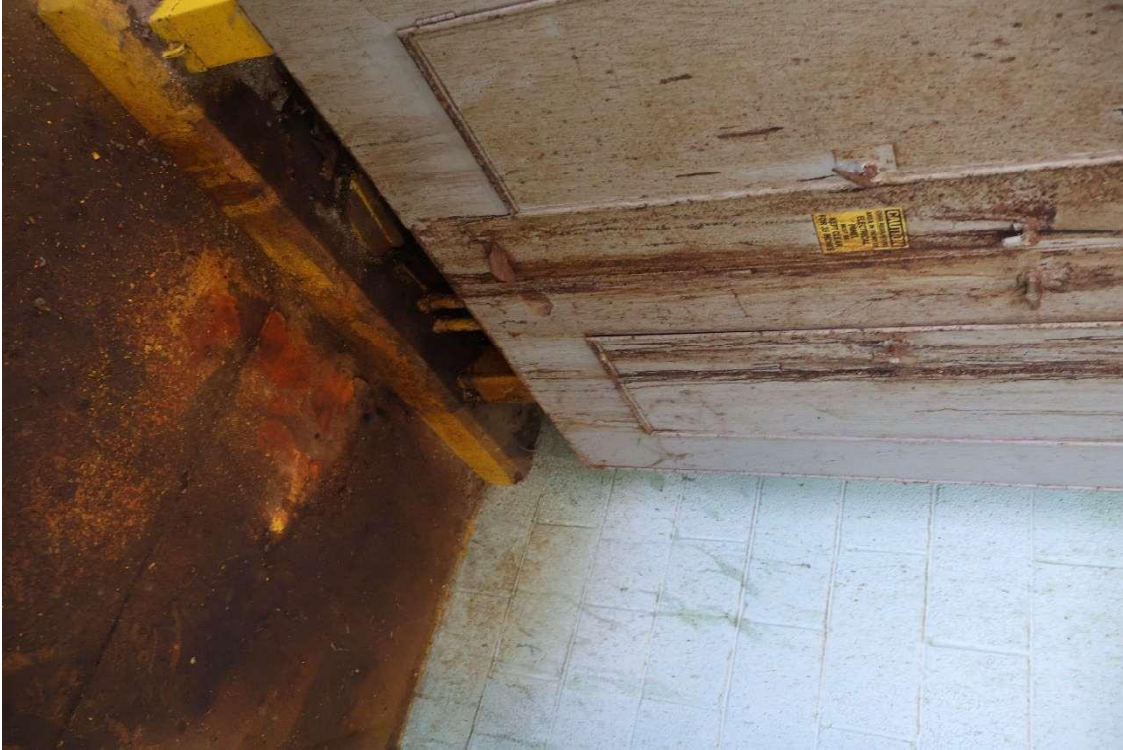
Evidence of leak at column K17

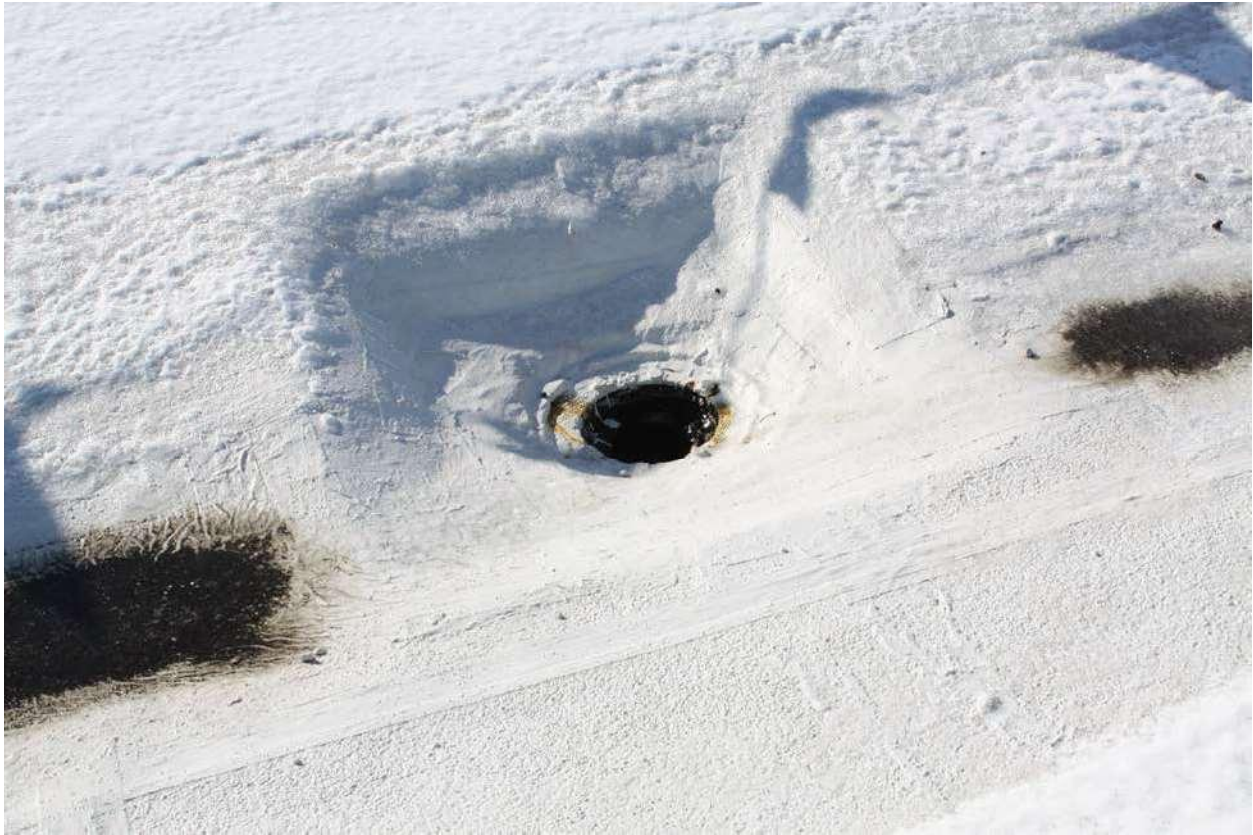
Main Low Roof – Missing Drain Screen

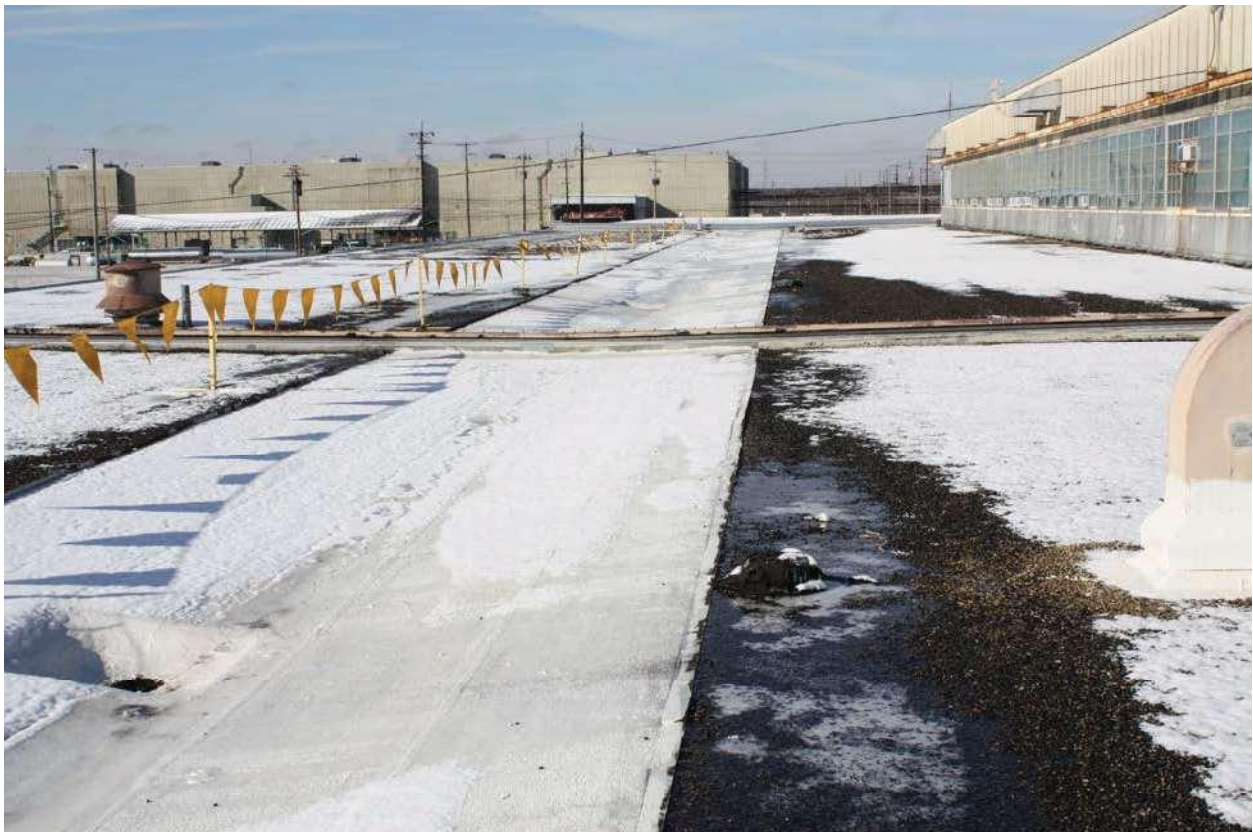
Looking West – Drain Screen Needs Replaced

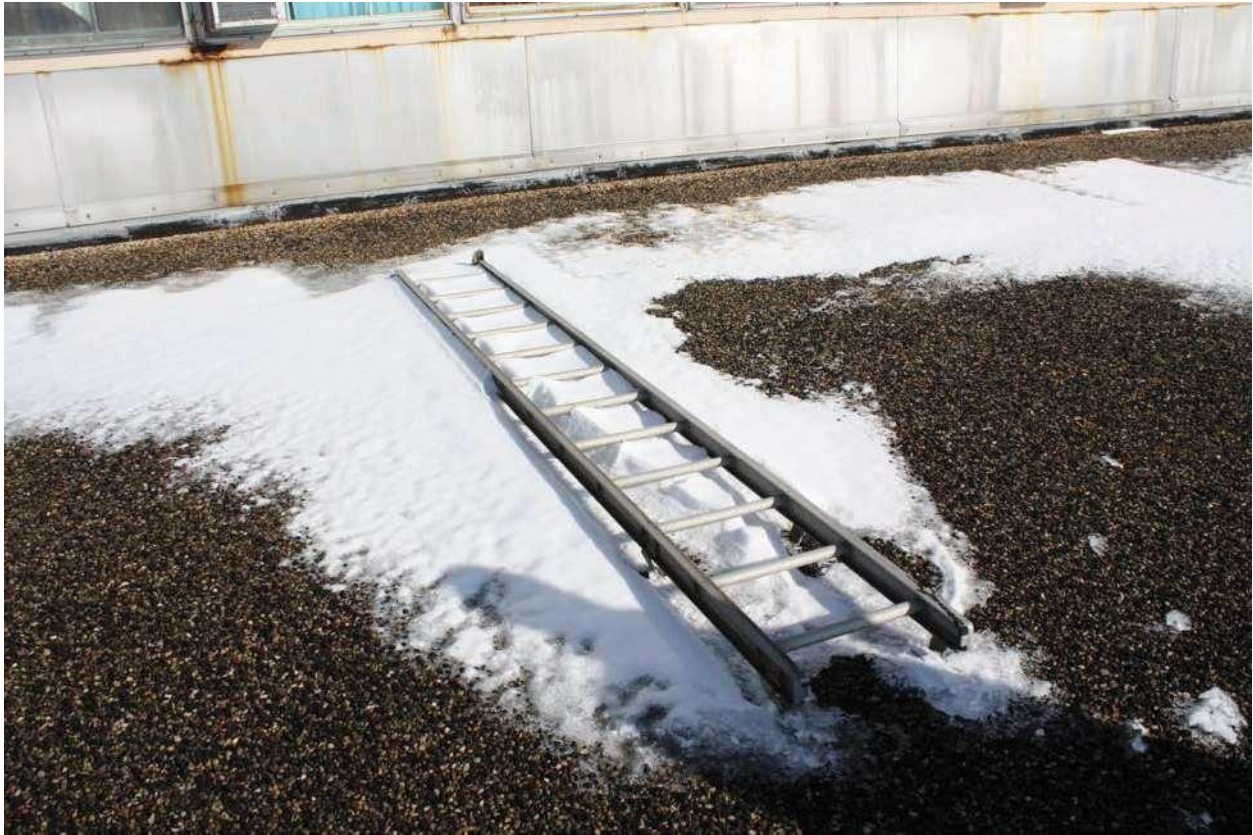
Debris to be Removed from Main Low Roof

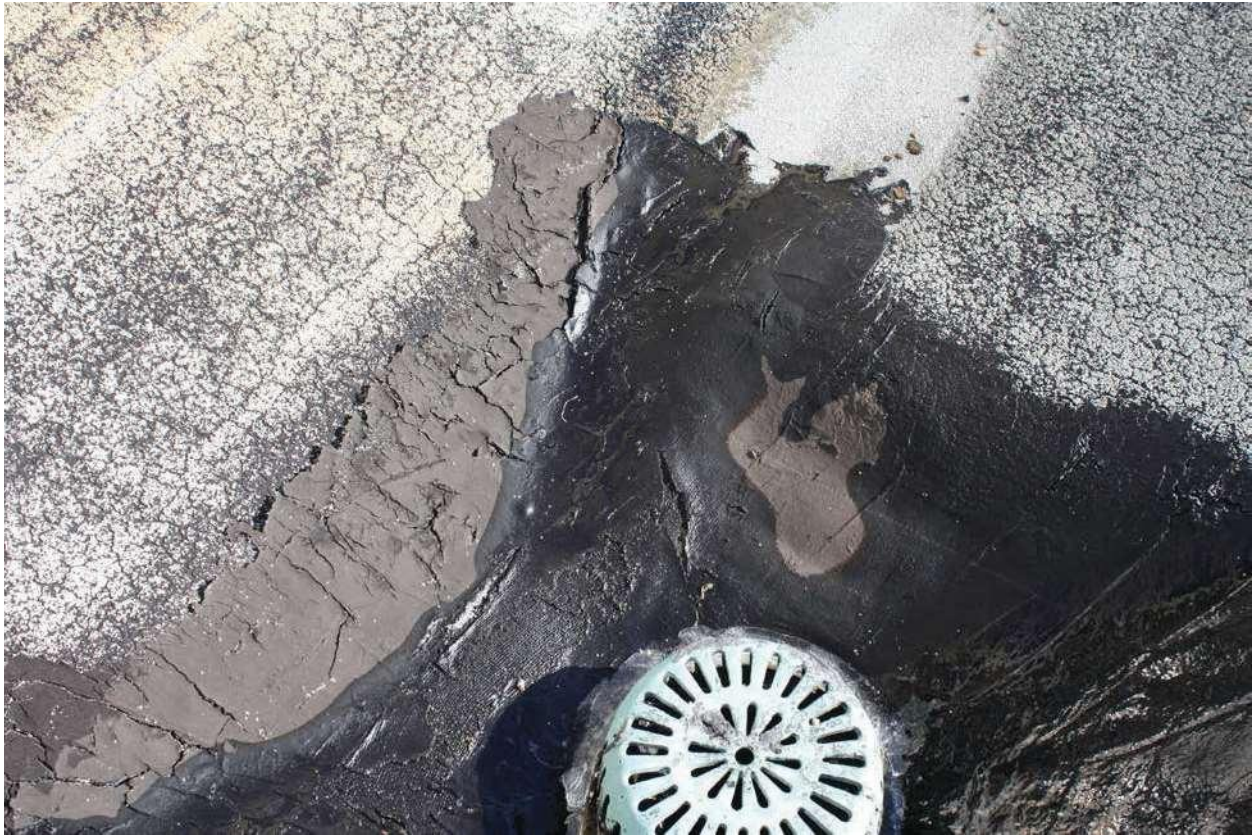
Minor Cracking at Roof Drain – Main Low Roof

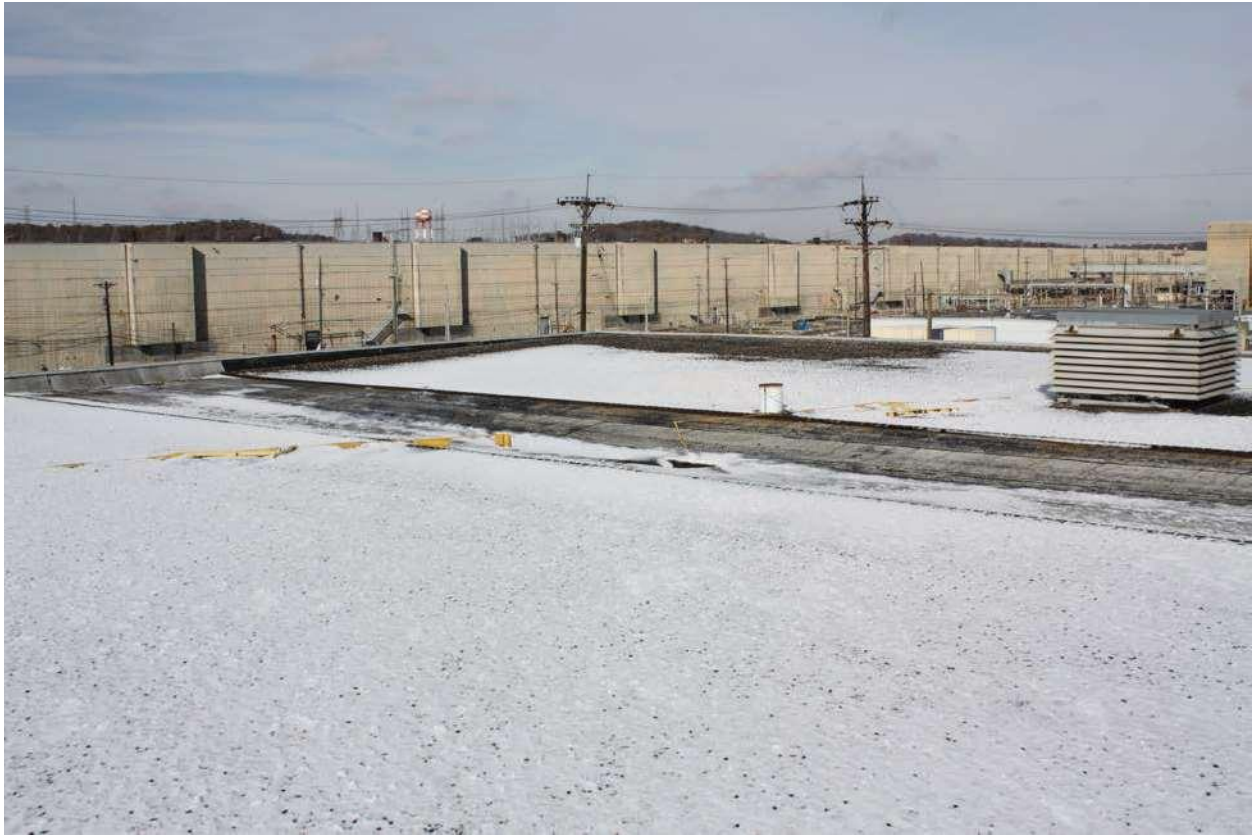
Looking Northwest – Highbay Roof, Stanchions to be Corrected

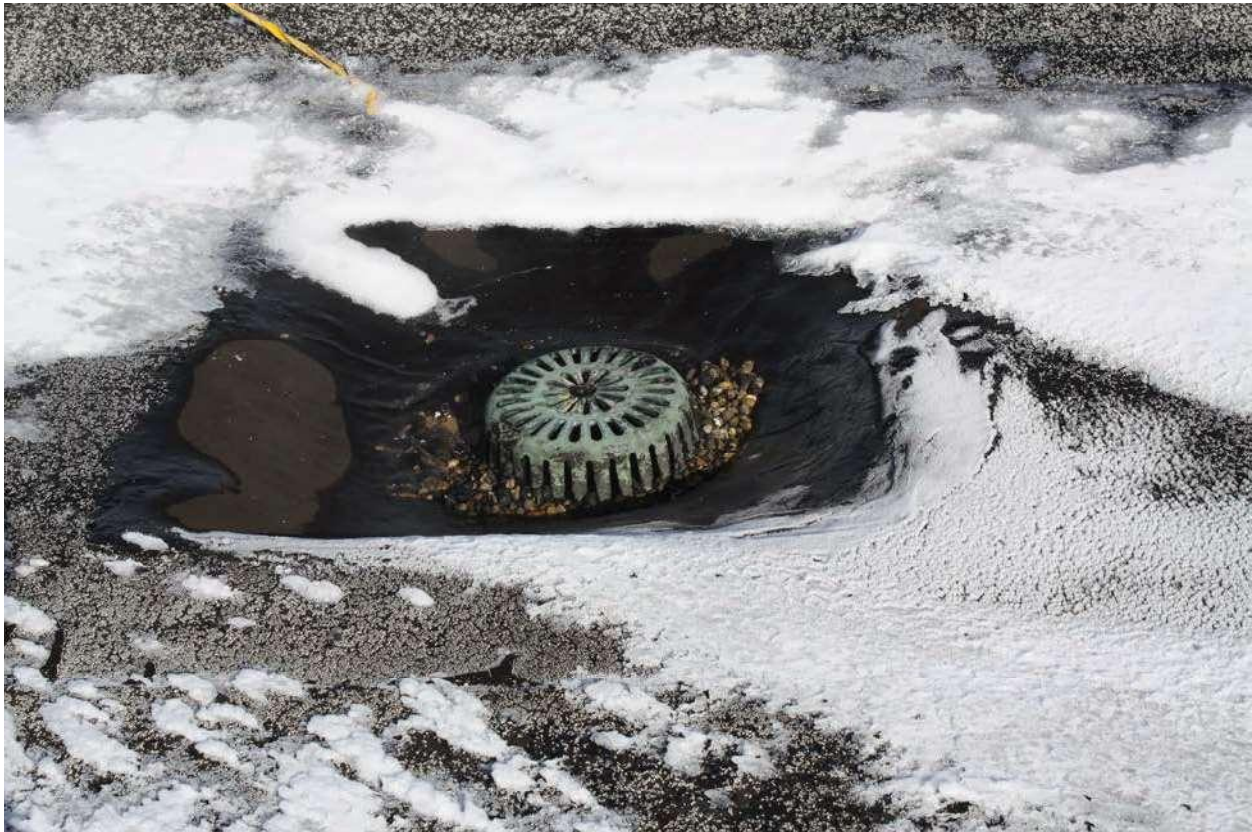
Highbay Roof Drain – Gravel Present at Drain to be Removed, Common
