## ENGINEERING EVALUATION COVERSHEET

**Number:** EVAL-DE-2020-0009

**Title:** X-720 Roof Inspection

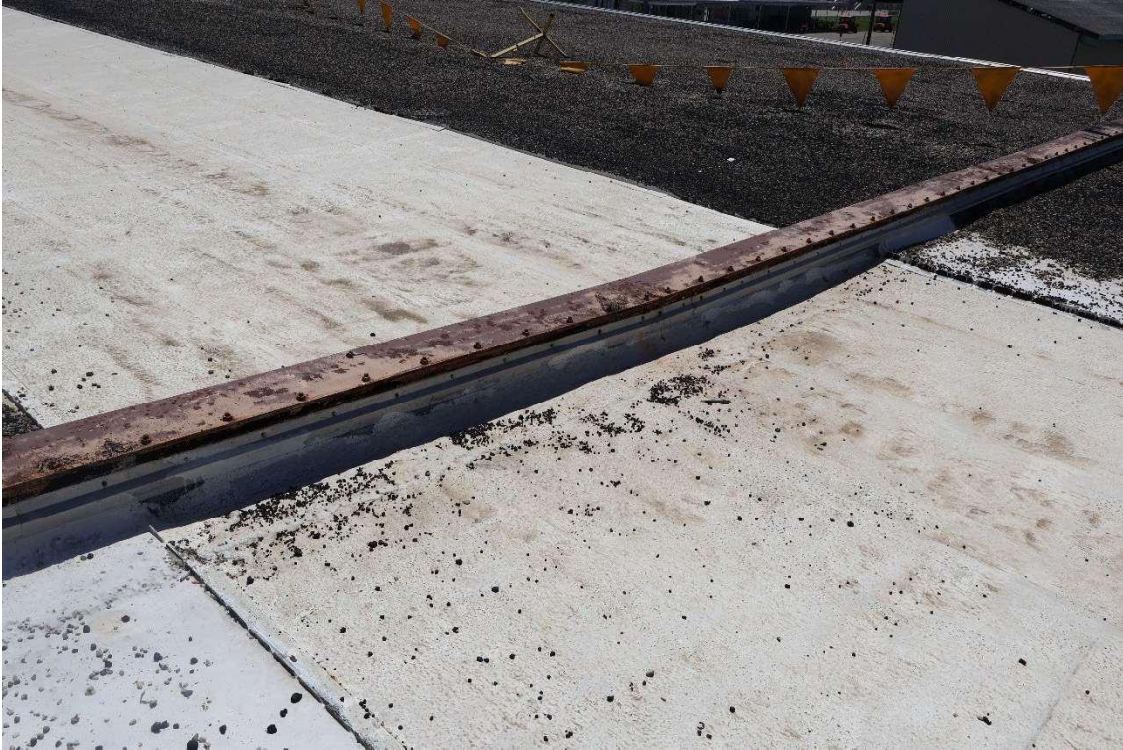
Main Low roof – Expansion Joint

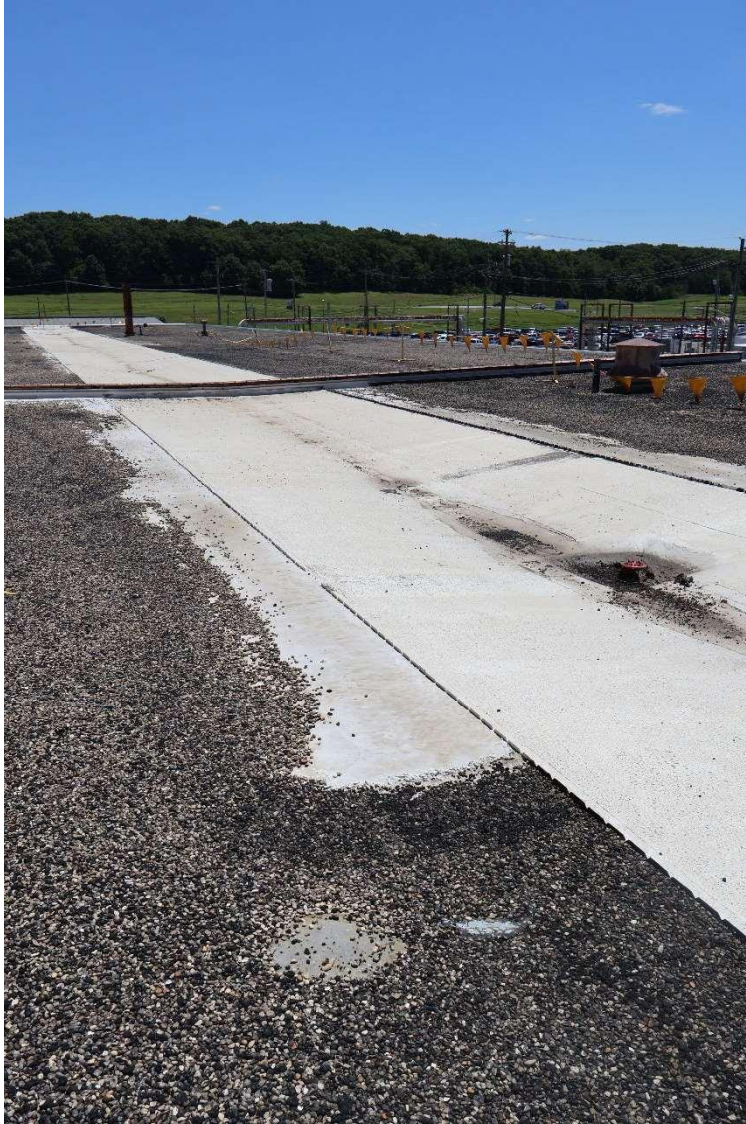
Main Low roof – Valleys shown and bare spots

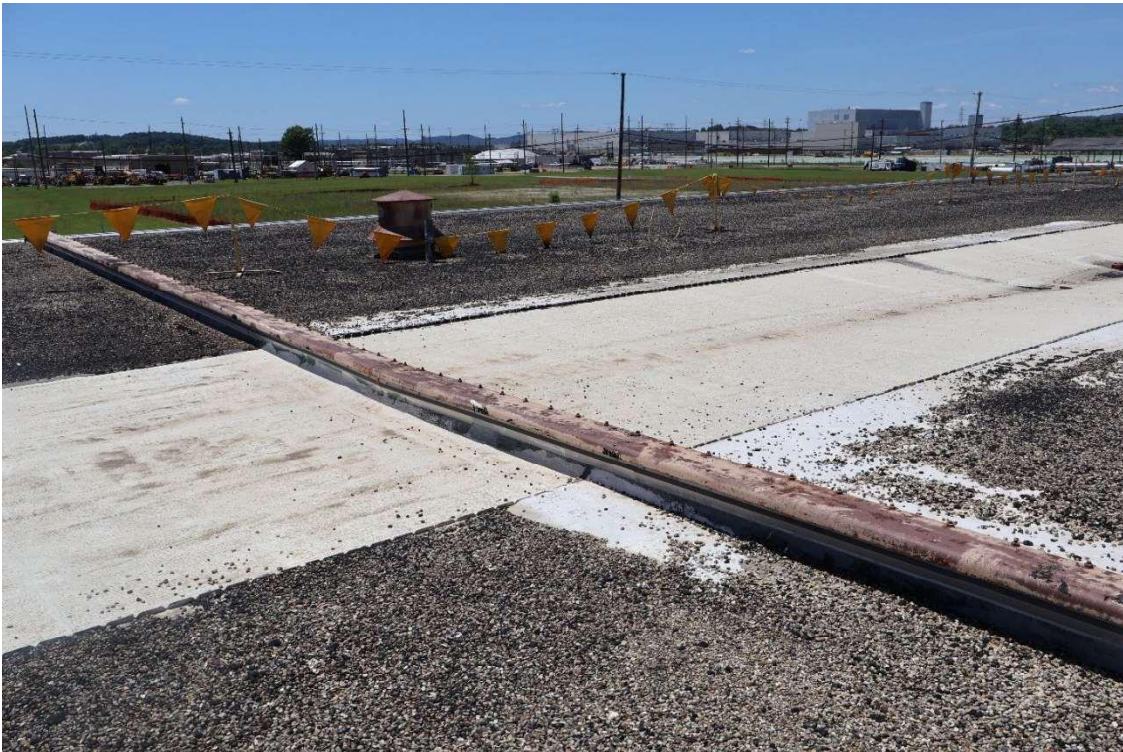
Main Low roof– Bare spot by expansion joint

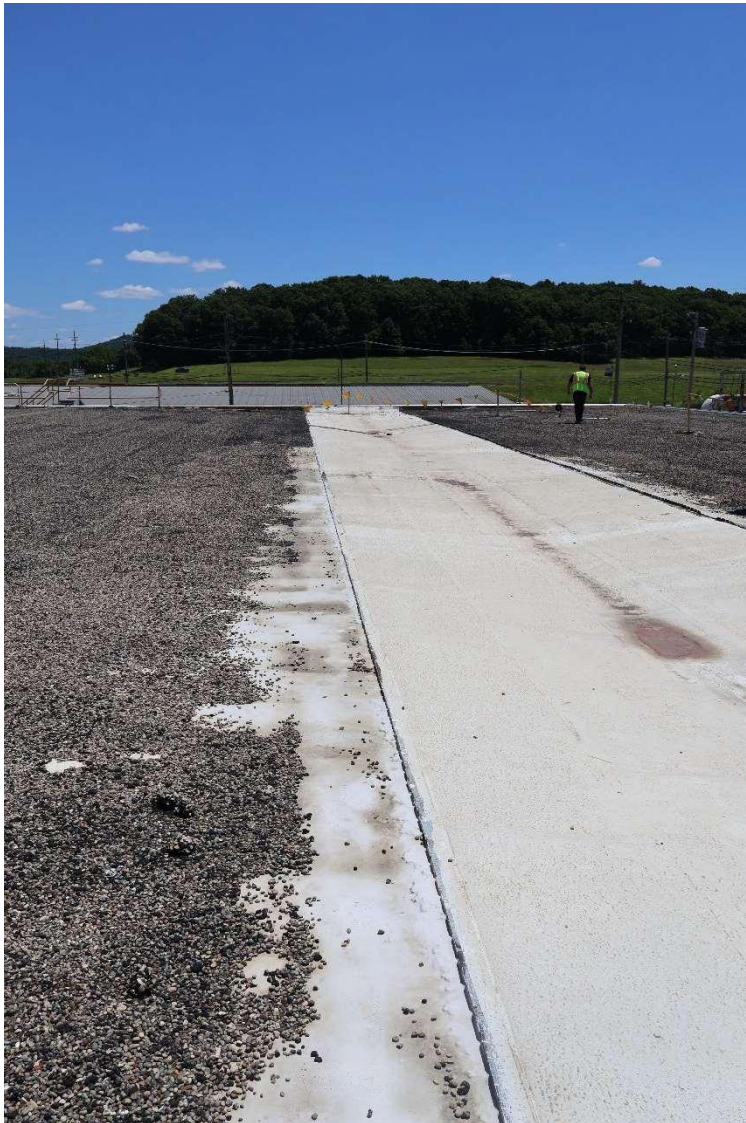
Main Low roof – Valley shown and bare spots

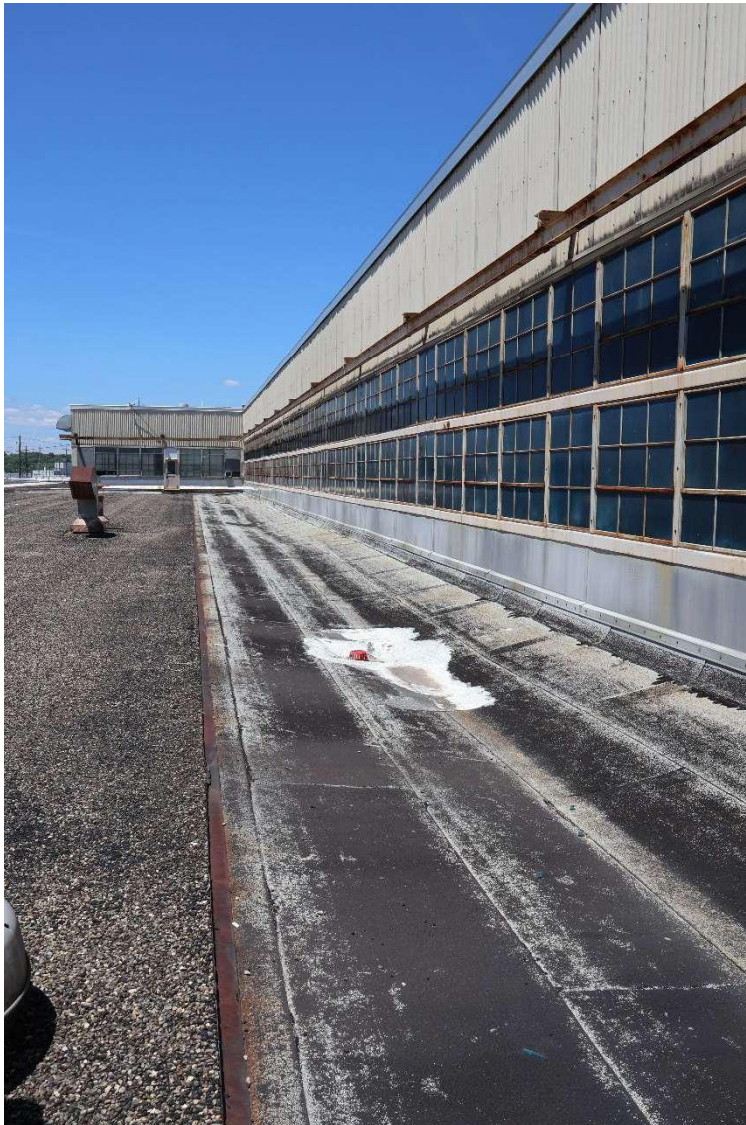
Main Low roof – Valleys near the main high roof

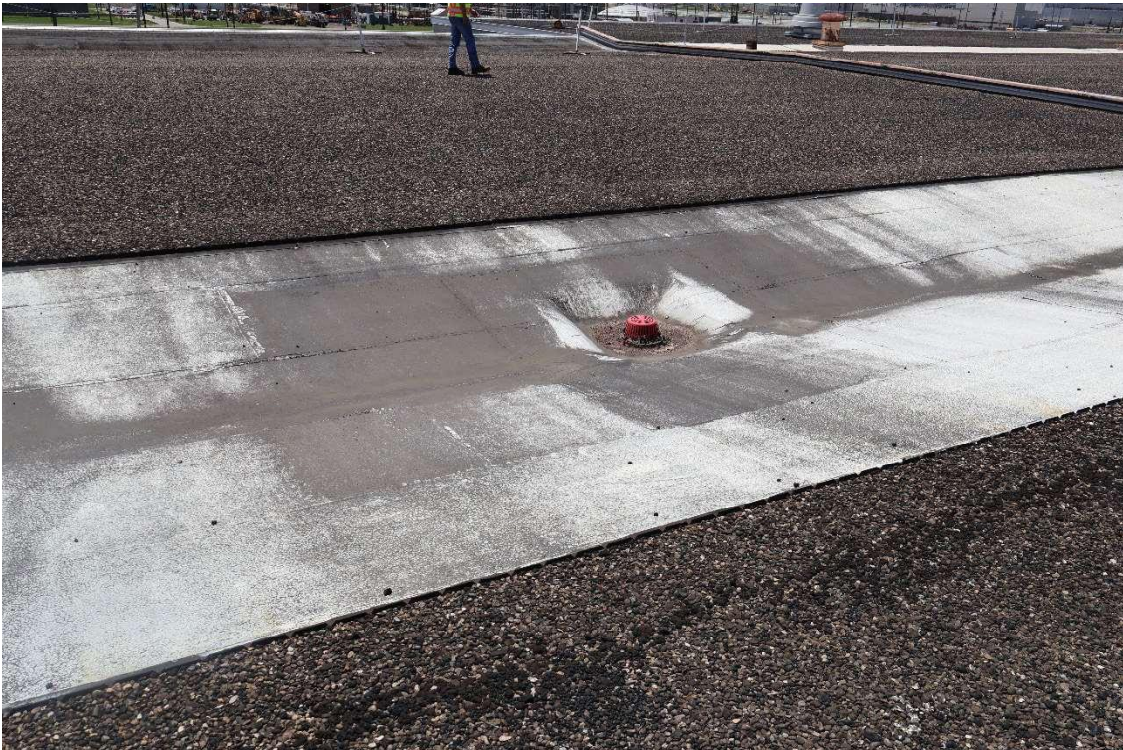
Main High roof – typical drain in valley

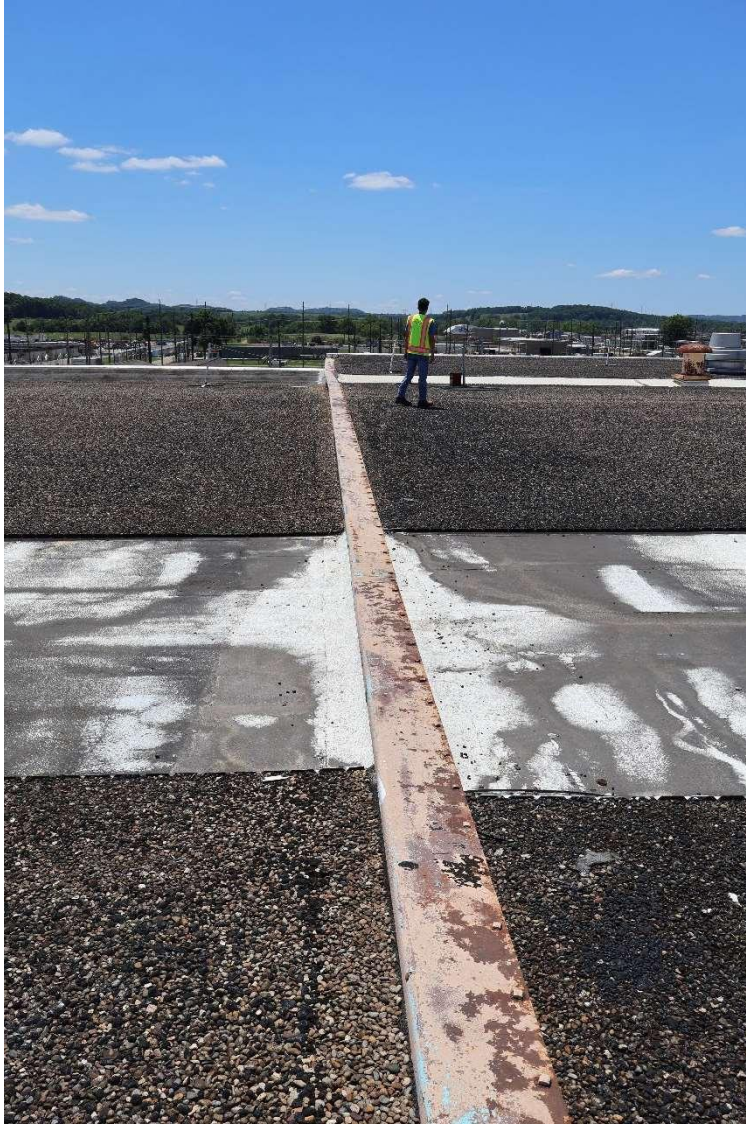
Main High roof – Expansion joint looking South

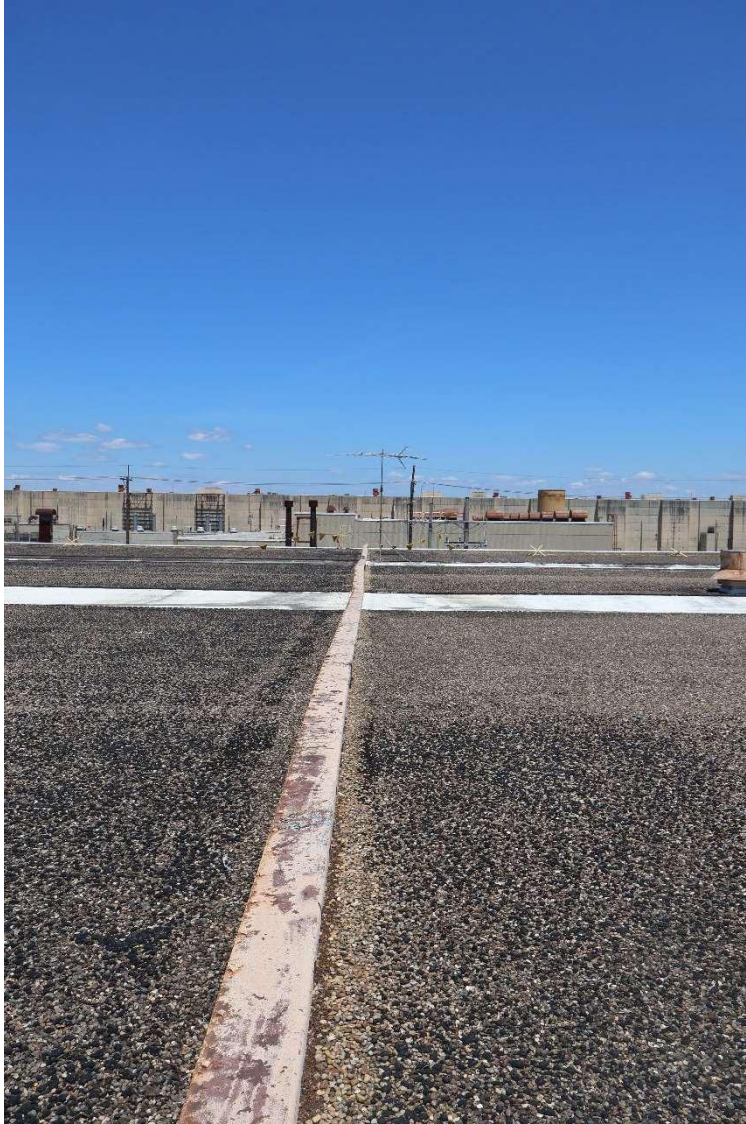
Main High roof – Expansion joint looking North

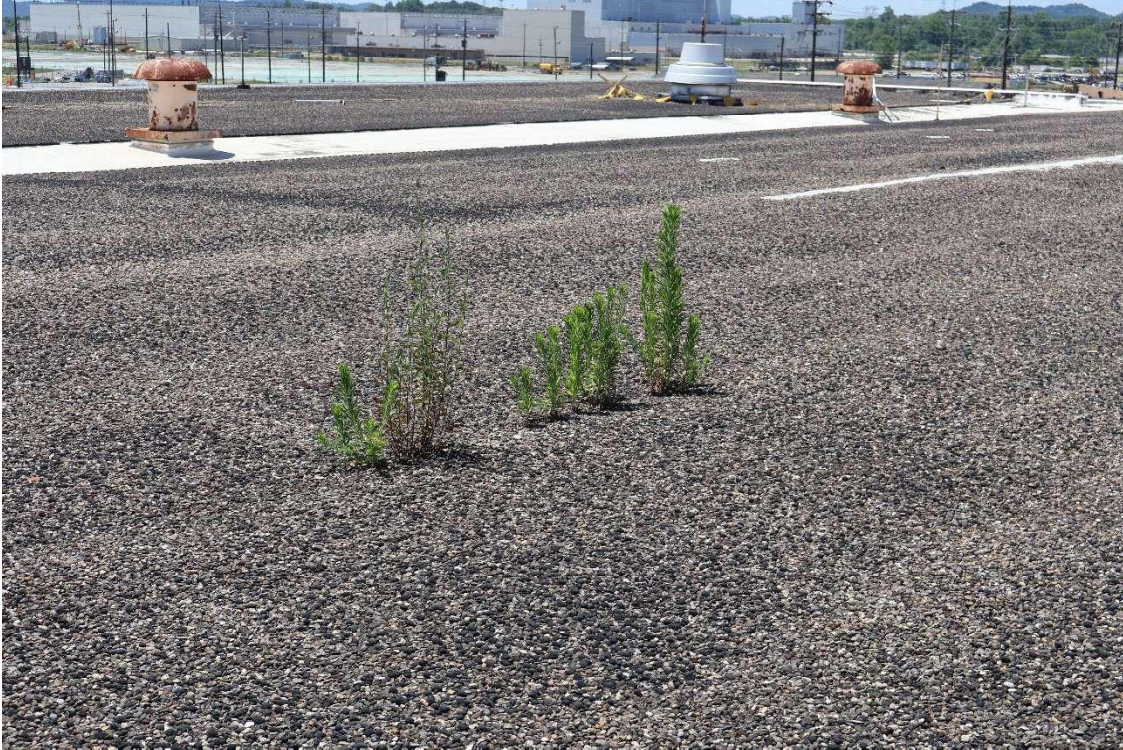
A walkdown of the X-720 roof was performed on June 13, 2024. Engineering found multiple locations on the roof where vegetation was growing. This could damage the TPO overlay and cause leaks in the future. While inspecting the interior of the roof, Engineering talked to personnel within the facility about leaks they have been noticing coming from the roof. The locations where leaks are present are listed above and pictures are provided in Attachment B. Engineering also found a spot of corroded metal decking near column J14 that needs to be monitored as part of this 5-year inspection.

Main High roof – Vegetation

- Repair roof leaks in multiple locations. The locations with roof leaks are found near columns B13, D15, B8, B10, E4, K2 and K17.
- Remove all vegetation growing on the roof.

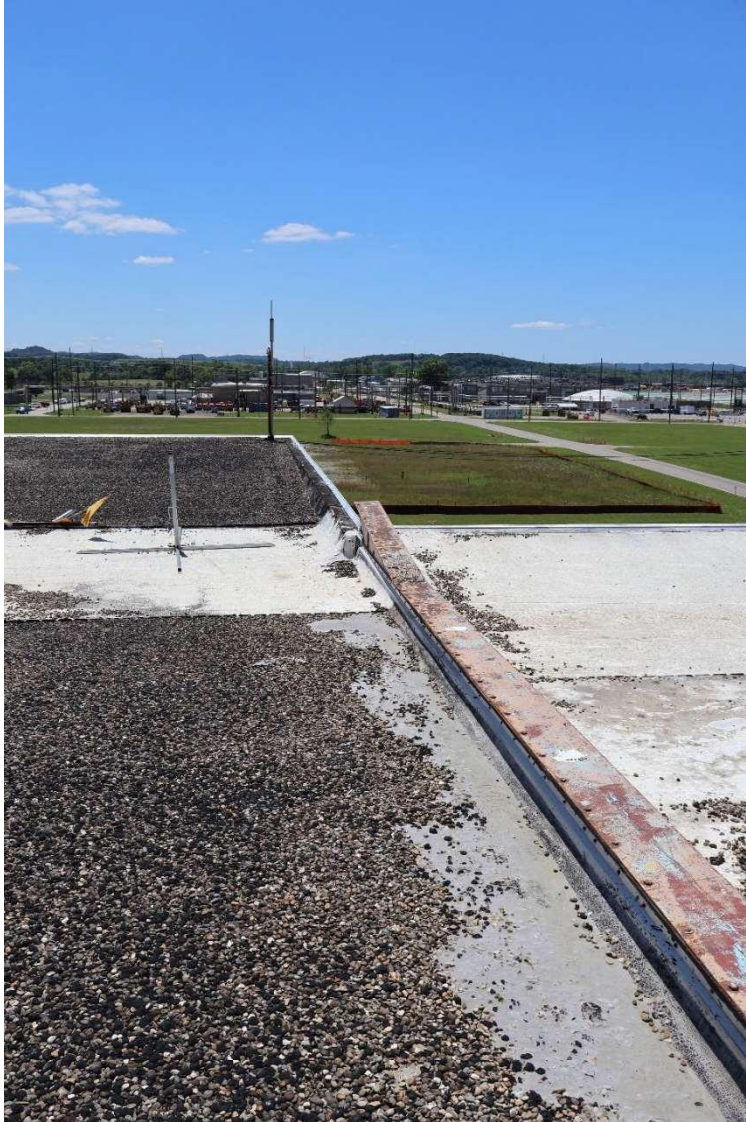
Main High roof – Expansion joint cover on South side is not secured

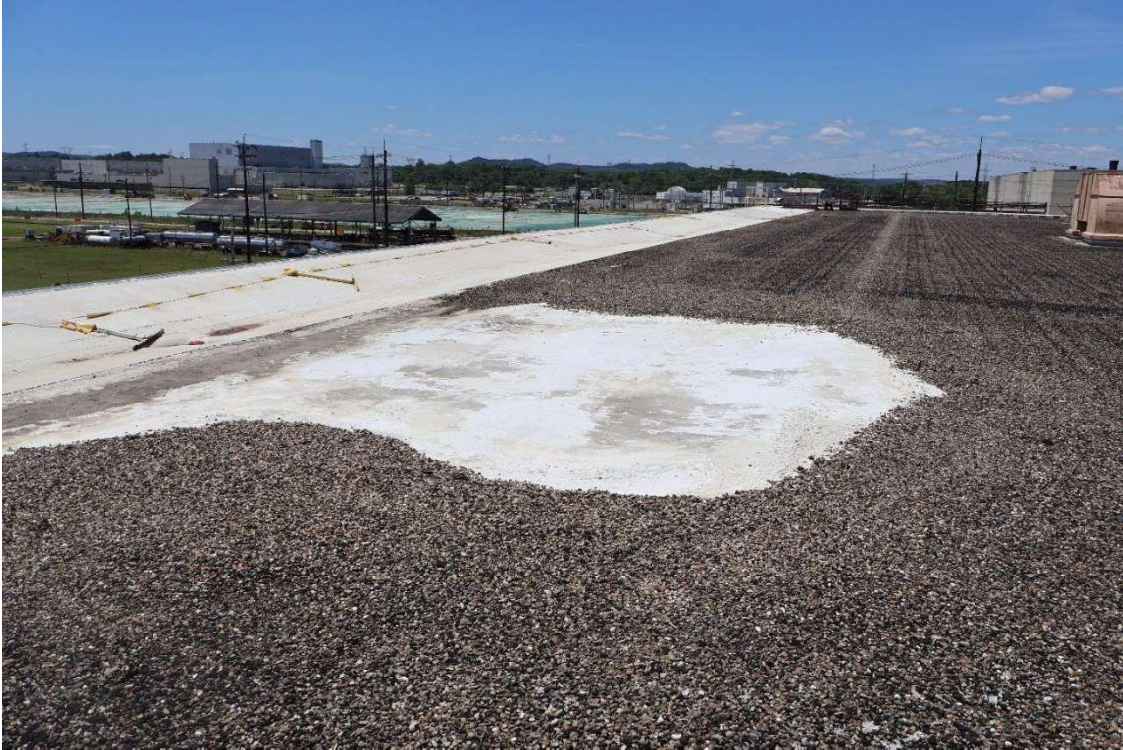
Main High roof – Large bare spot

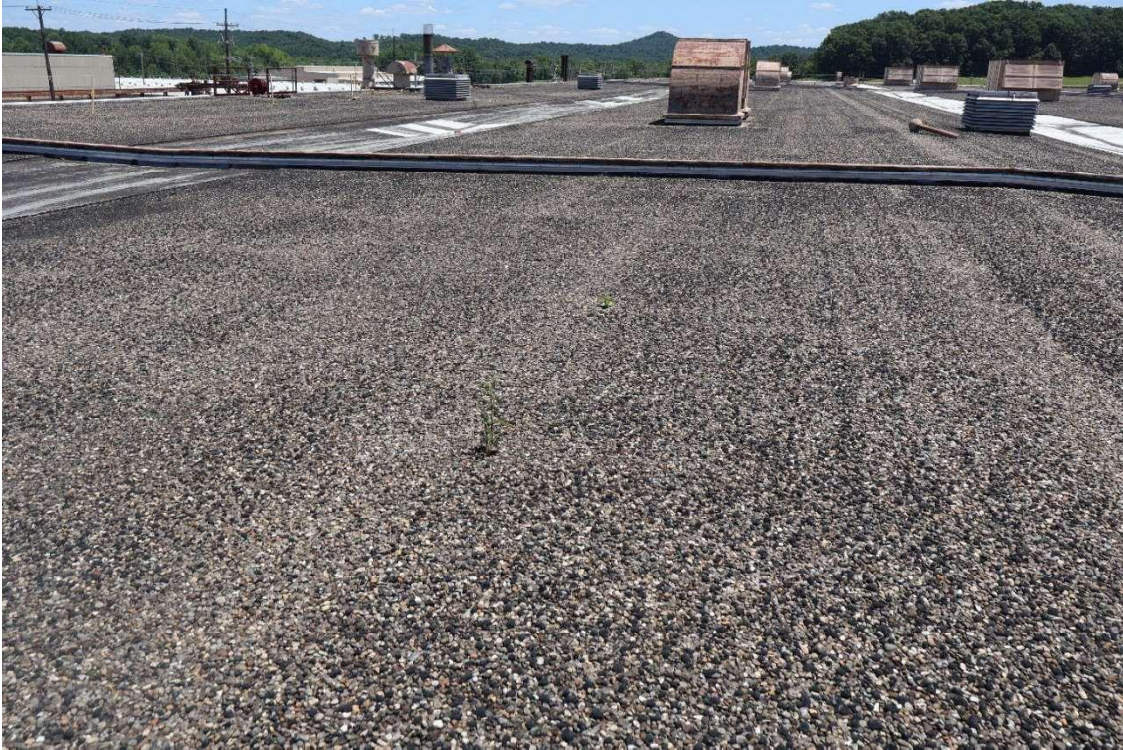
Main High roof – Vegetation

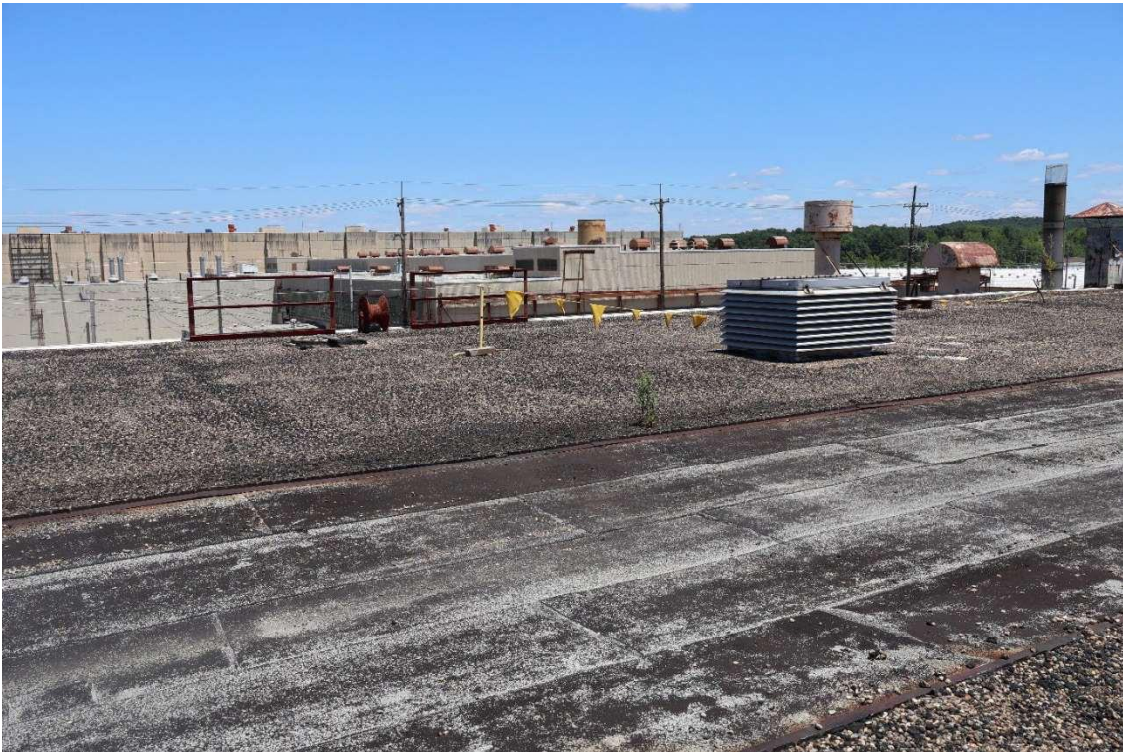
Main High roof – More vegetation on North side

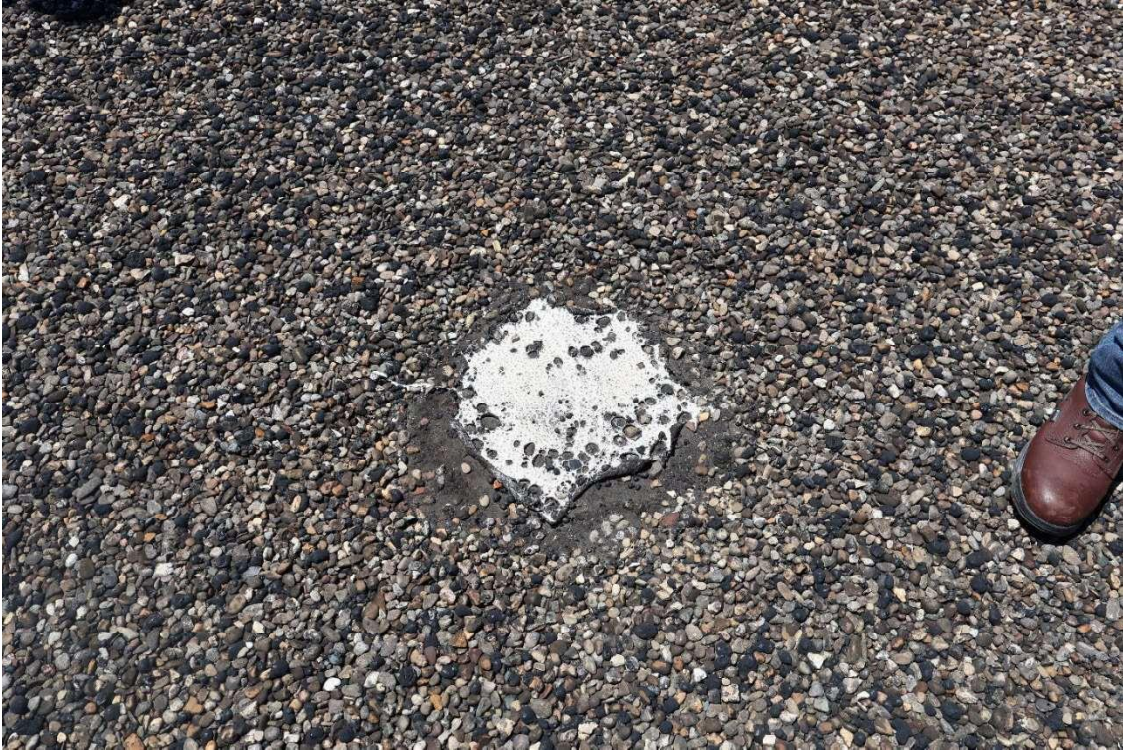
Main High roof – Possible repair/patch work

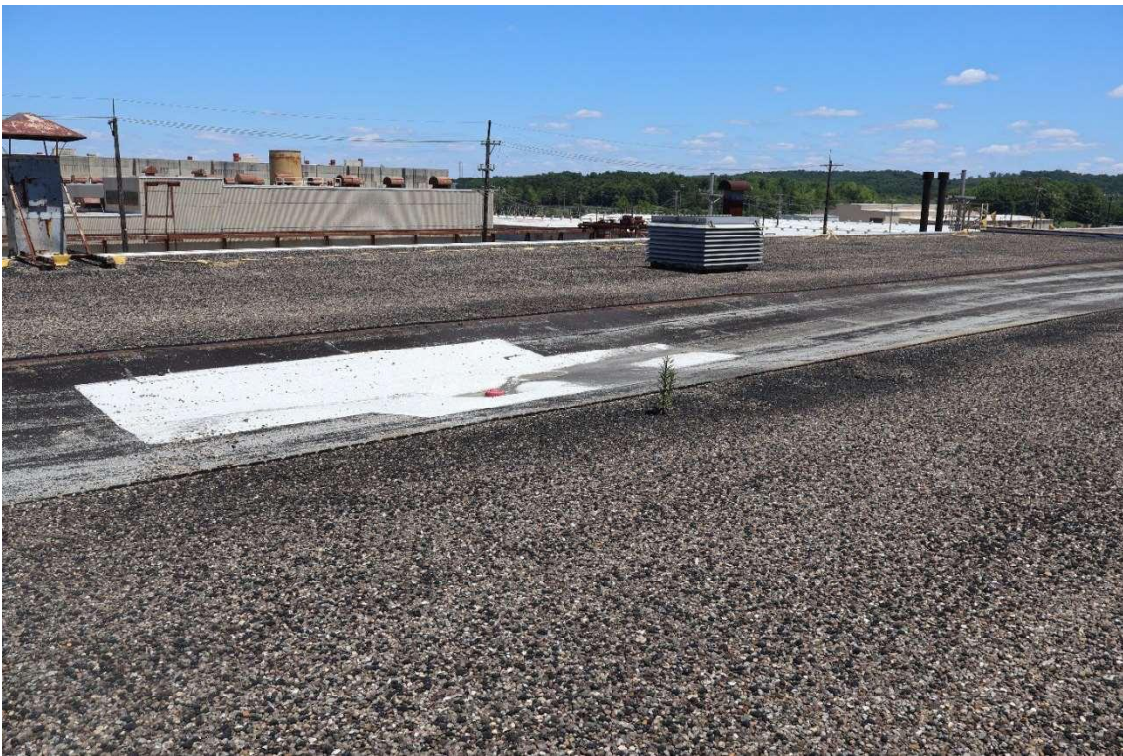
Main High roof – Vegetation on North side

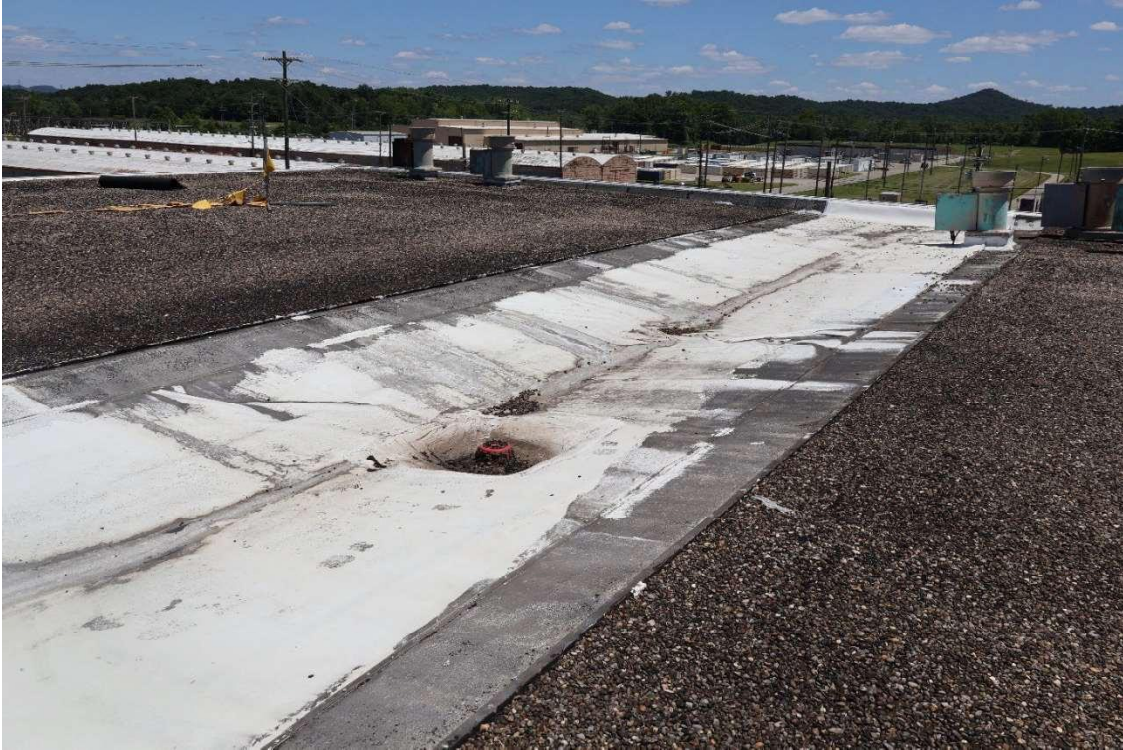
Main High roof – Gravel in the valley from runoff

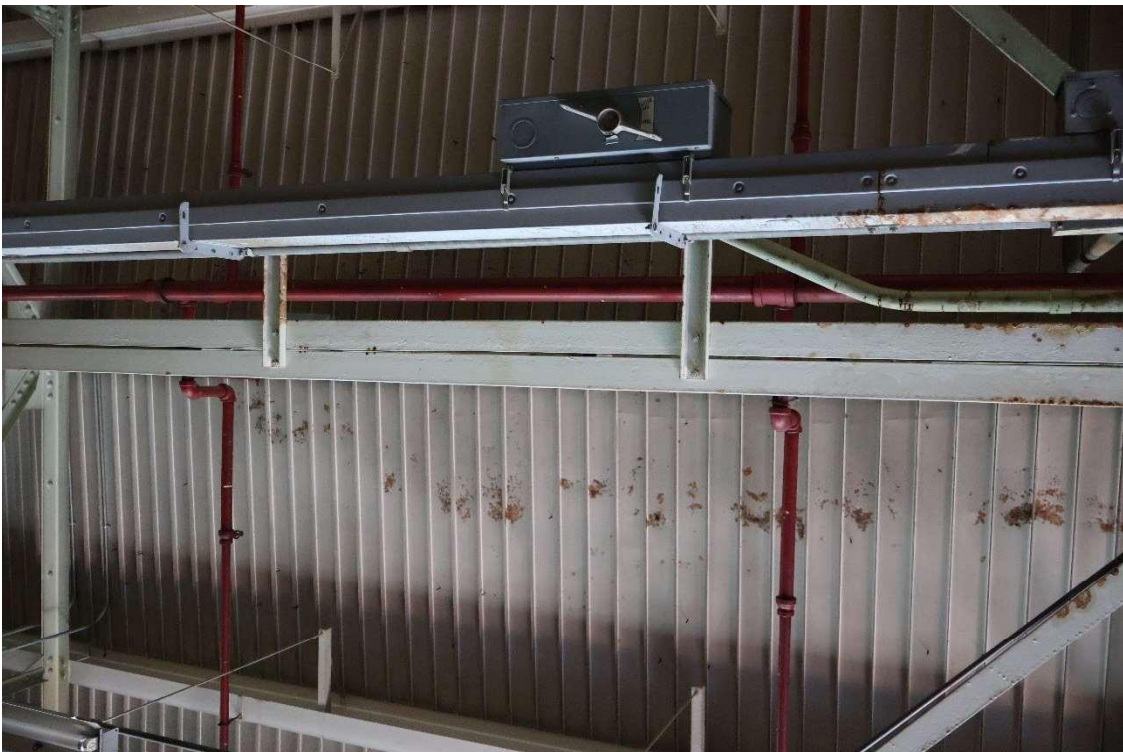
Evidence of leaks near column B13

Roof above the picture shown above, at column B13

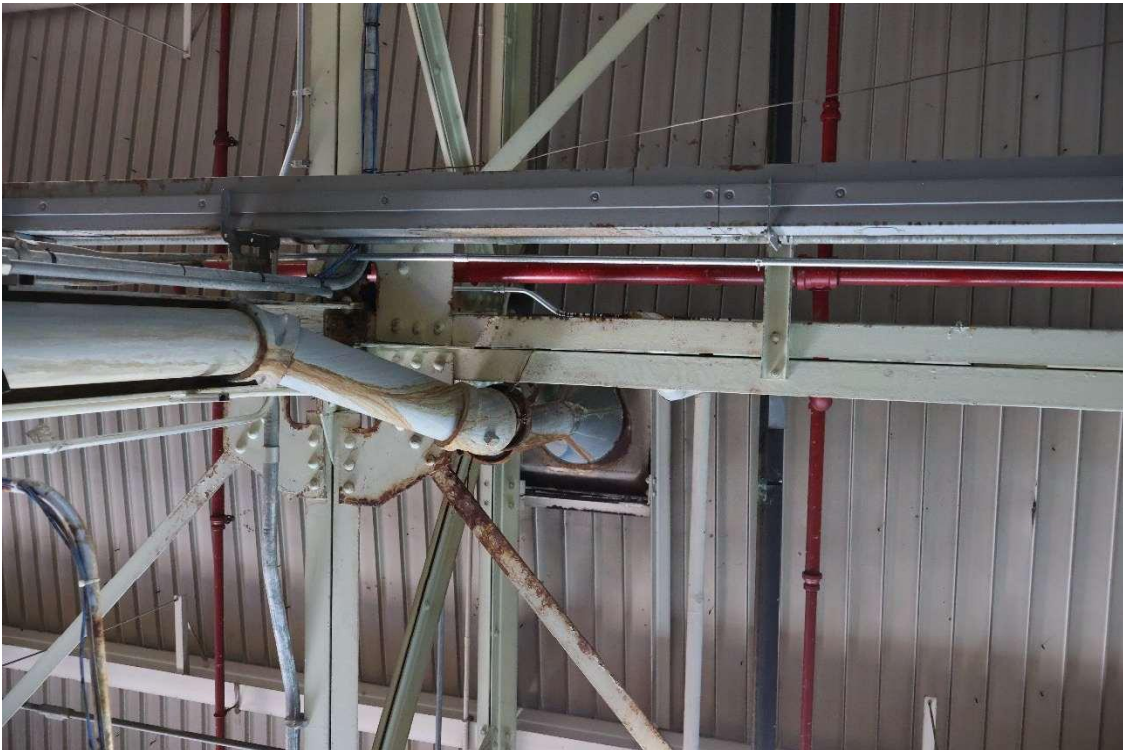
Water damage at column B15

Roof at column B15 where the leak is coming from

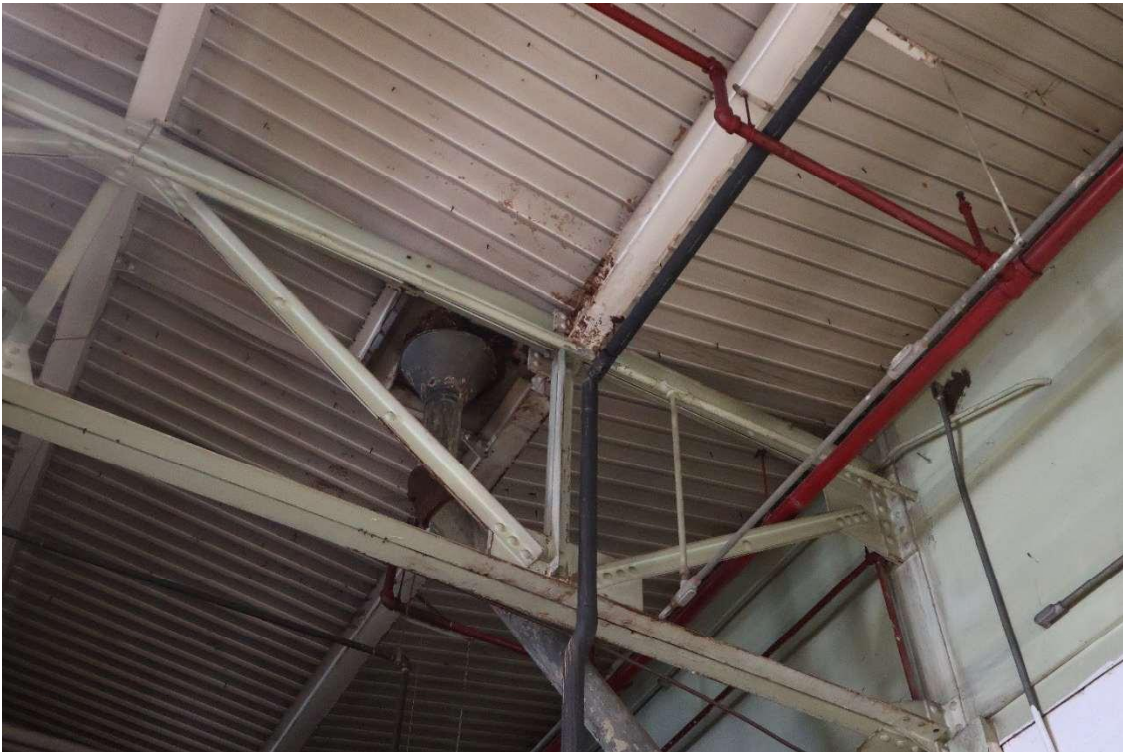
Leak at column D15

Roof at column D15

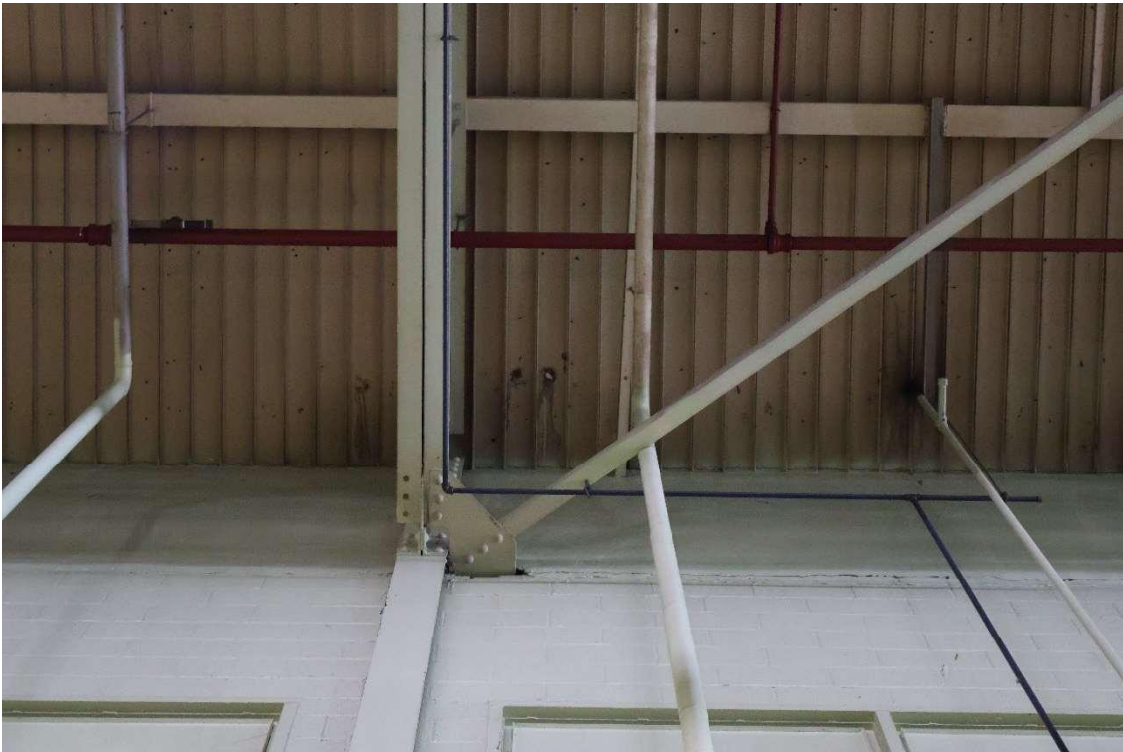
Minor holes near column D7

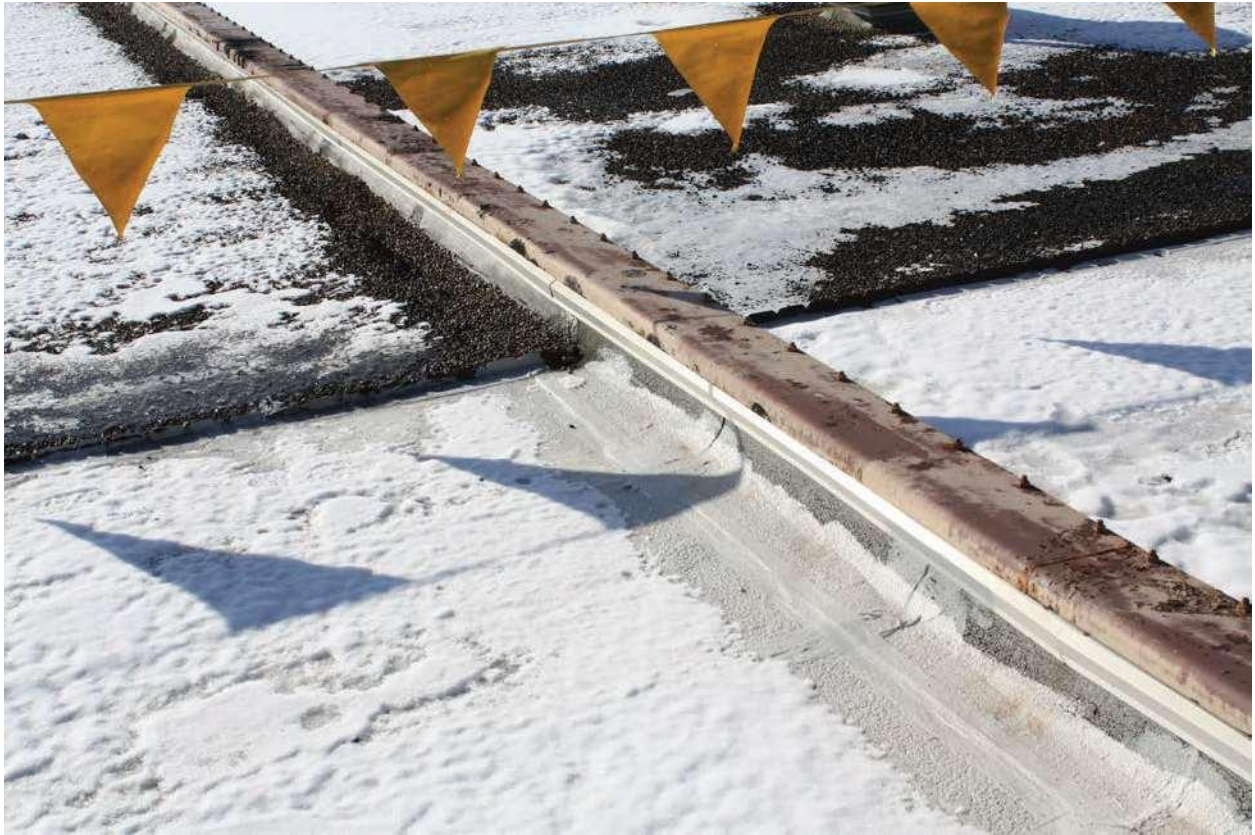
Looking West on Main Low Roof

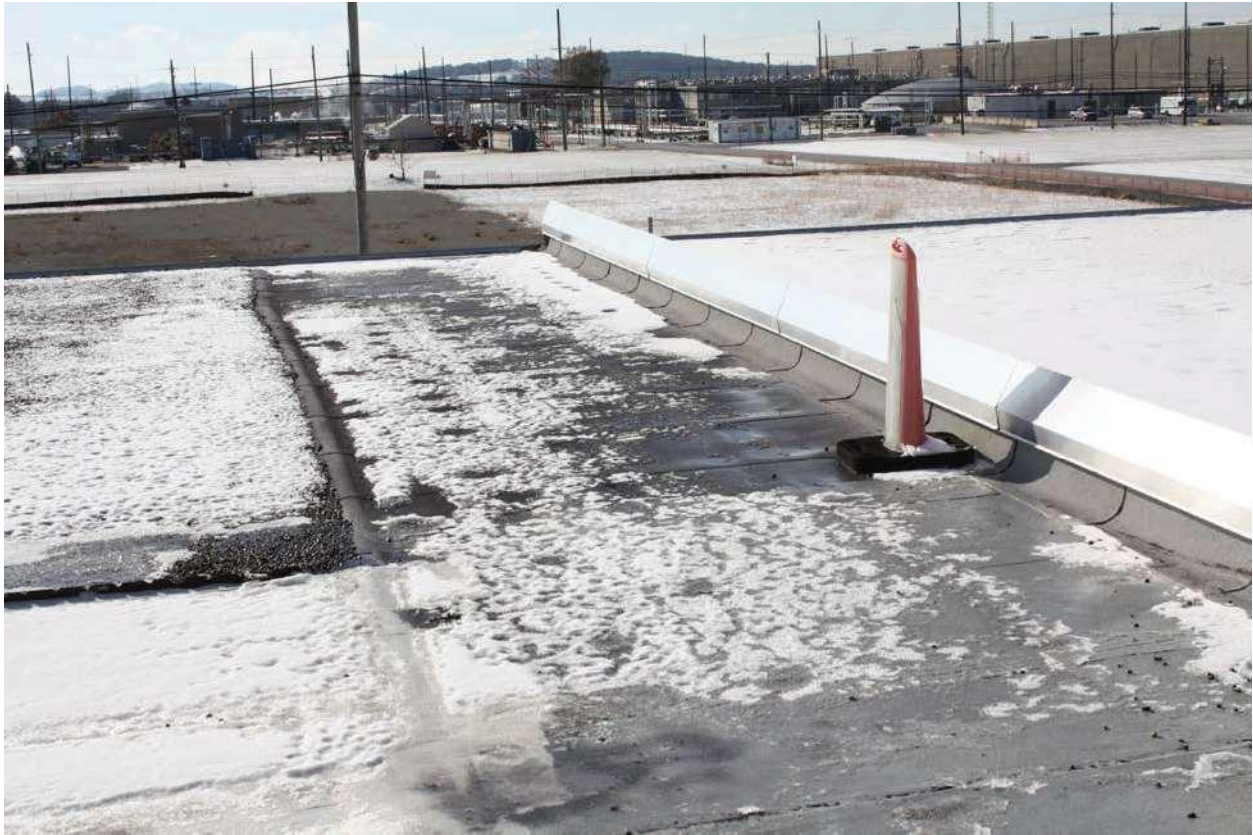
Looking West – New TPO on Main Low Roof

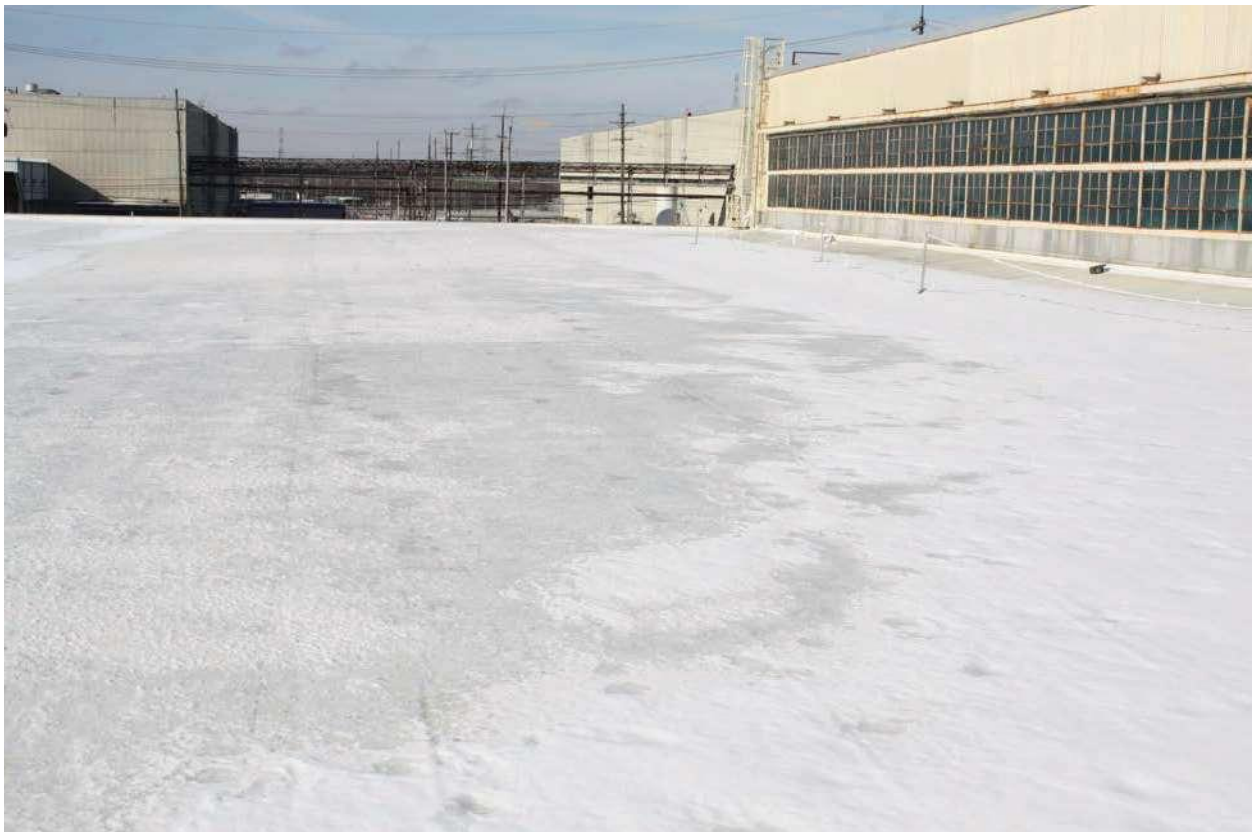
Looking Southwest – New TPO on Main Low Roof

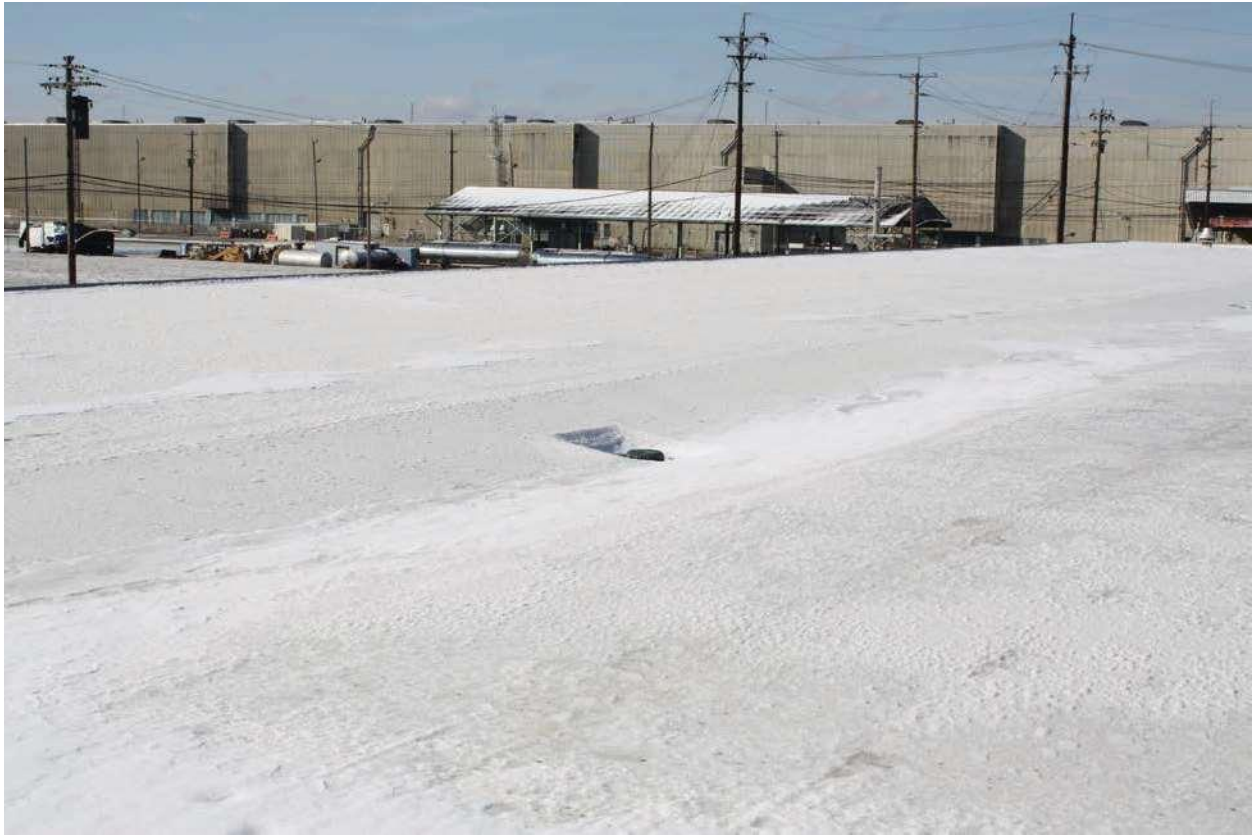
Looking Northwest – New TPO on Main Low Roof

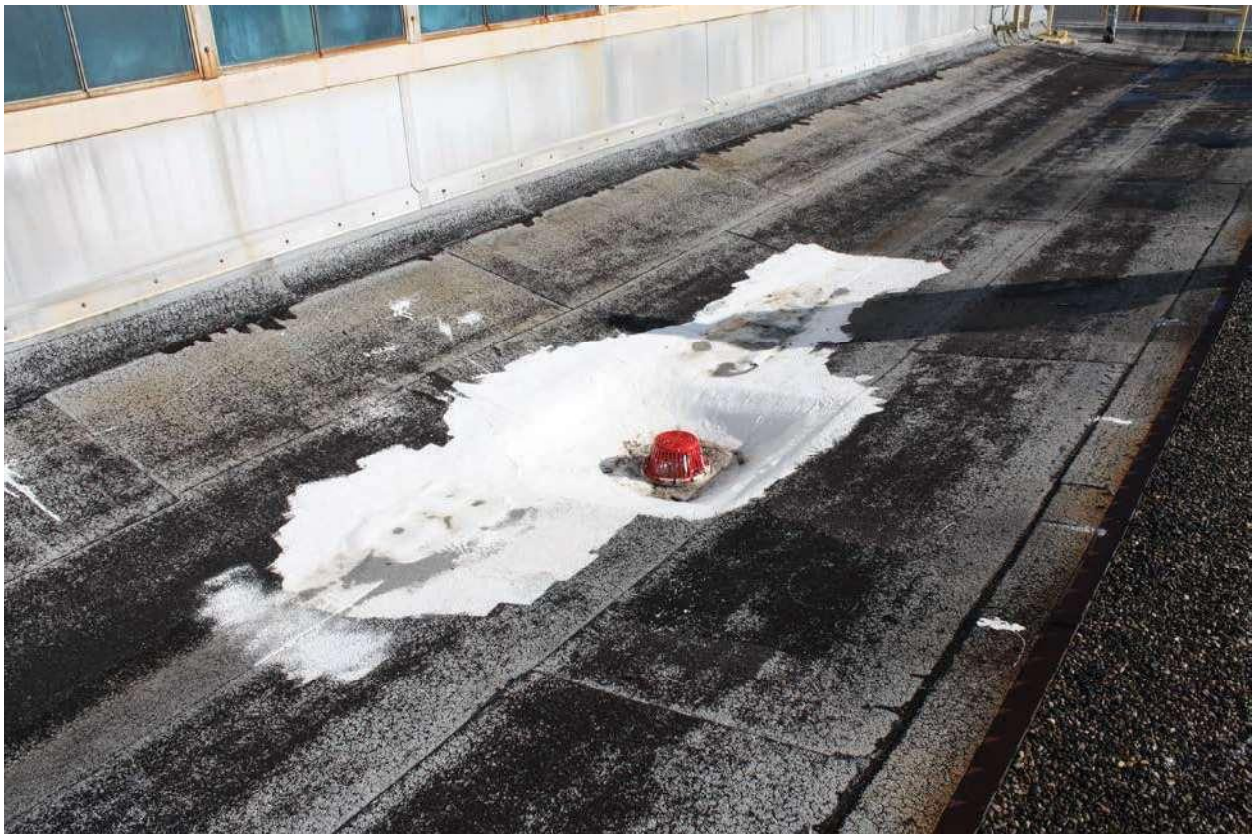
Looking North – Highbay Roof
