## ENGINEERING EVALUATION COVERSHEET

**Number:** EVAL-DE-2020-0009

**Title:** X-720 Roof Inspection

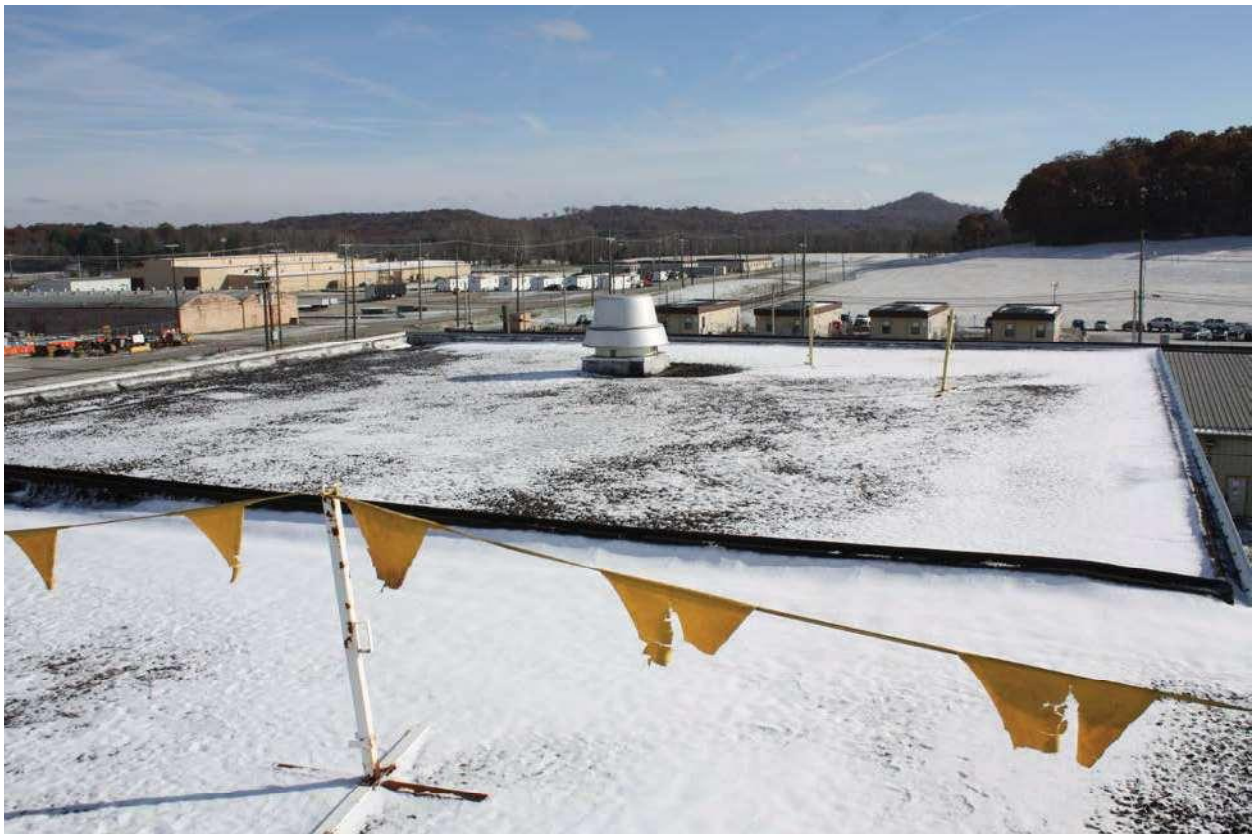
Looking East – Building Addition Roof (No Physically Walkdown)

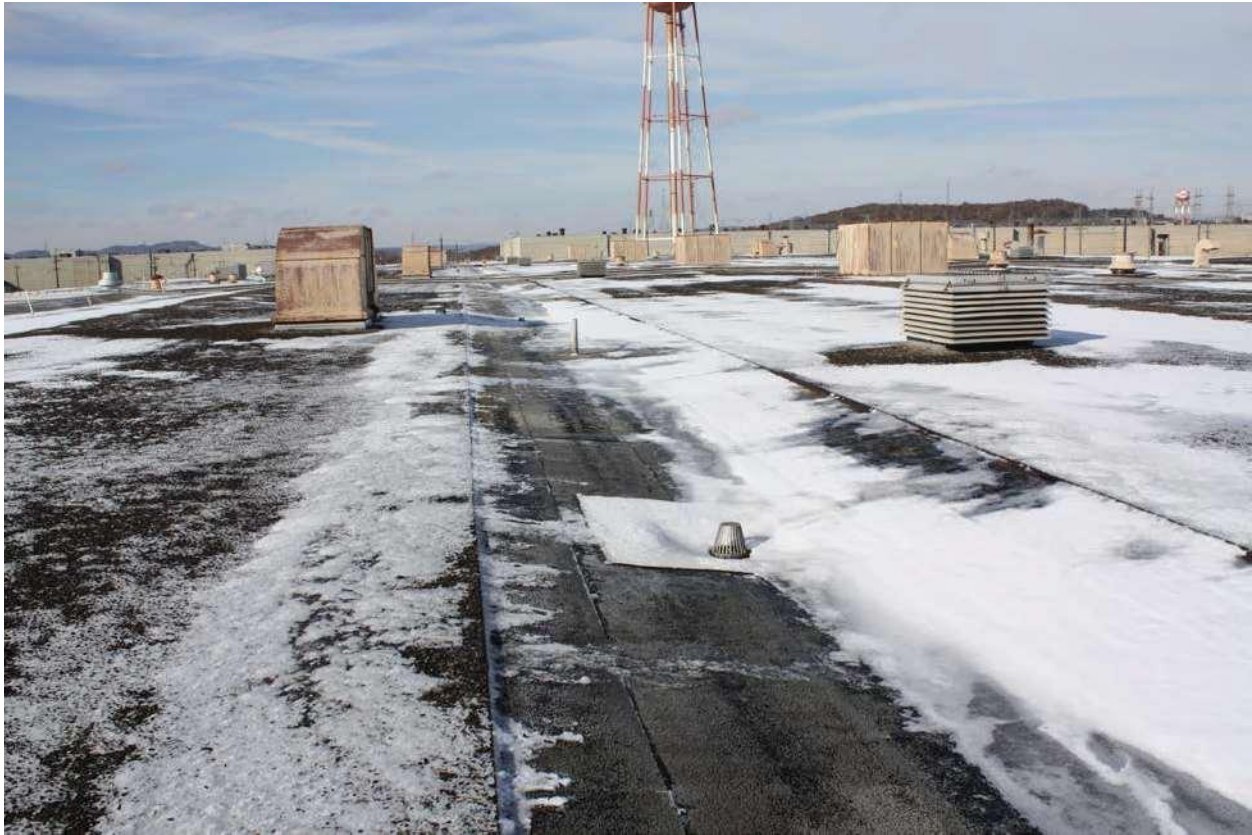
Looking West – Highbay Roof

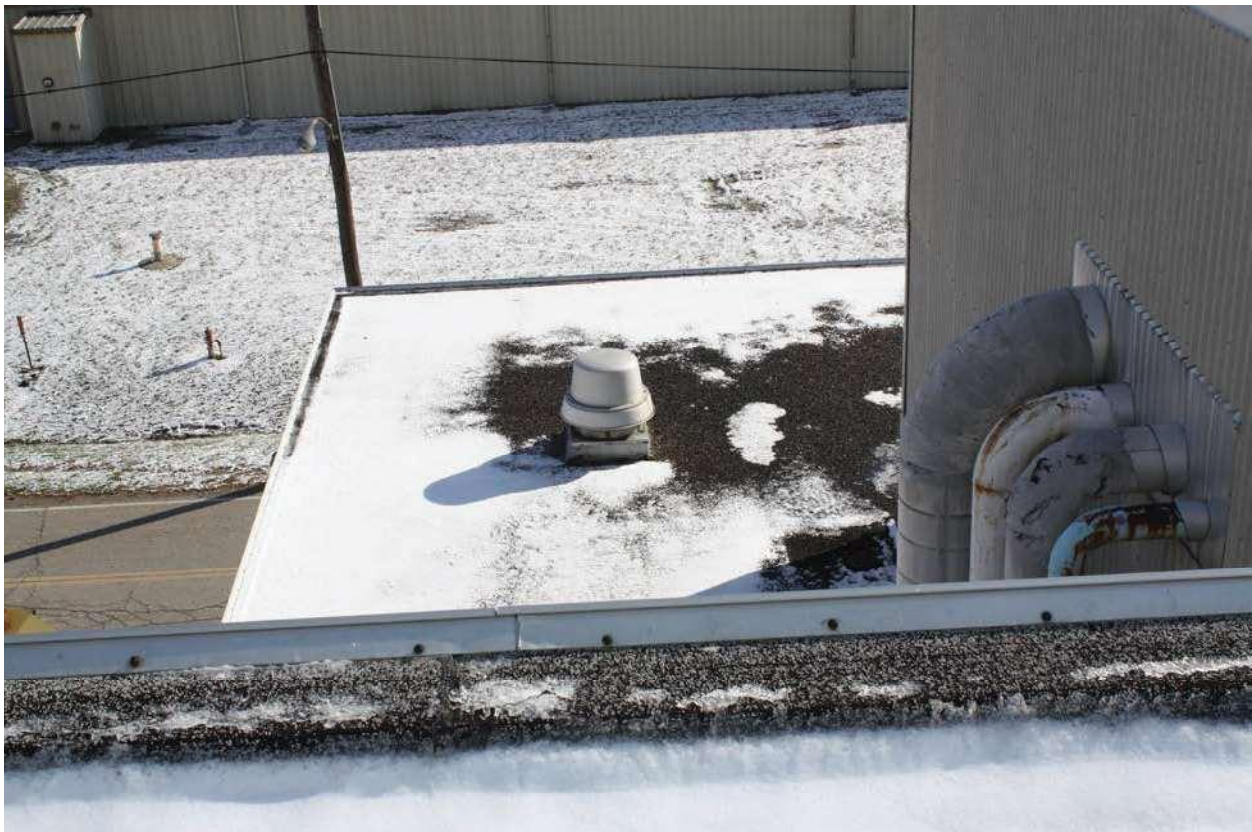
Looking East – Lower Roof of Building Addition (No Physical Walkdown)

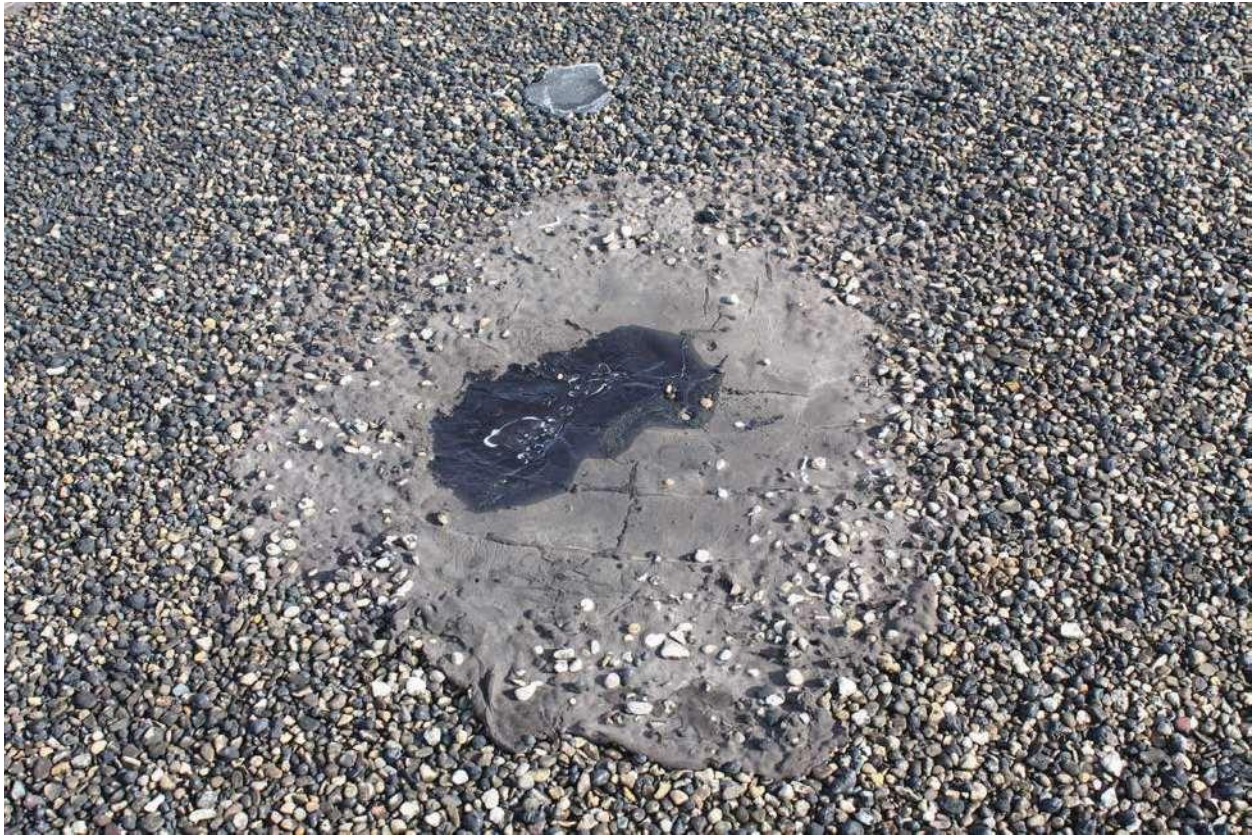
Highbay – Patching of Built-up Roof

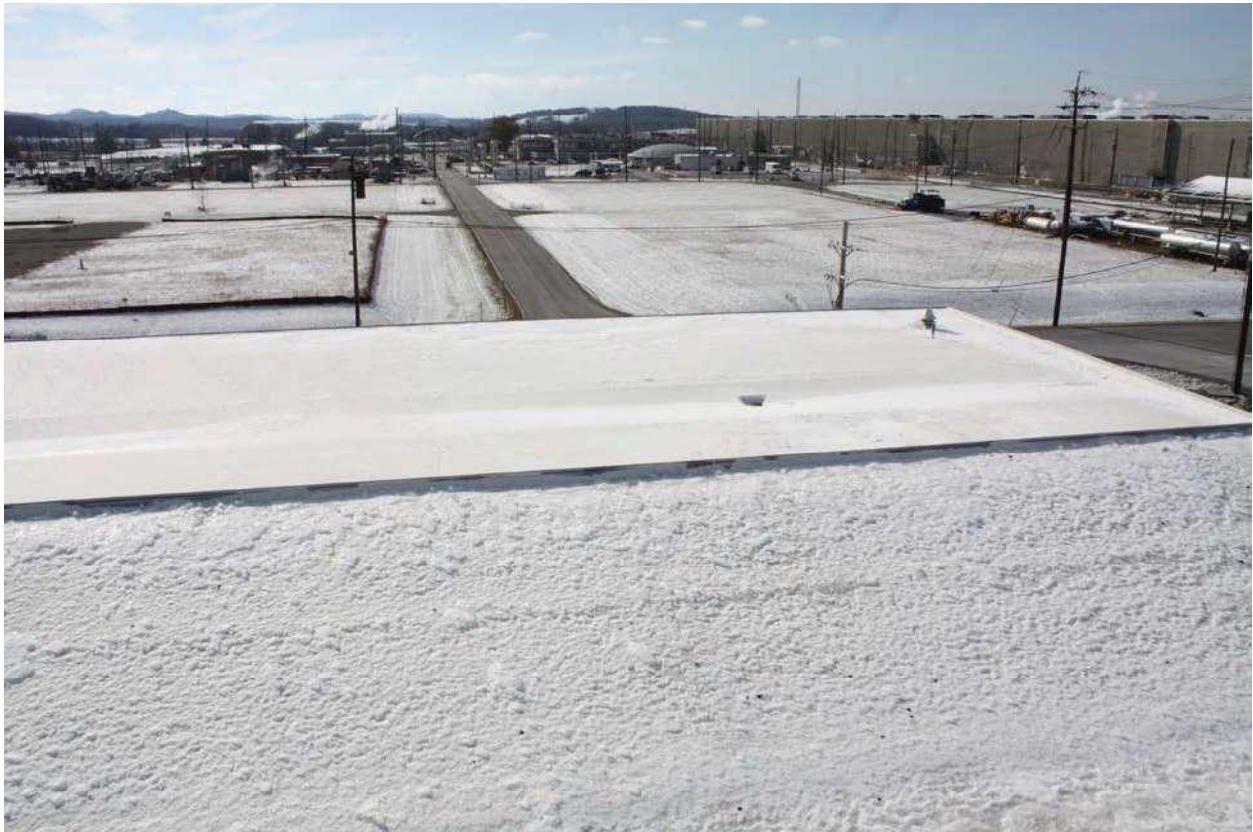
Looking South from Highbay at New TPO on Main Low Roof

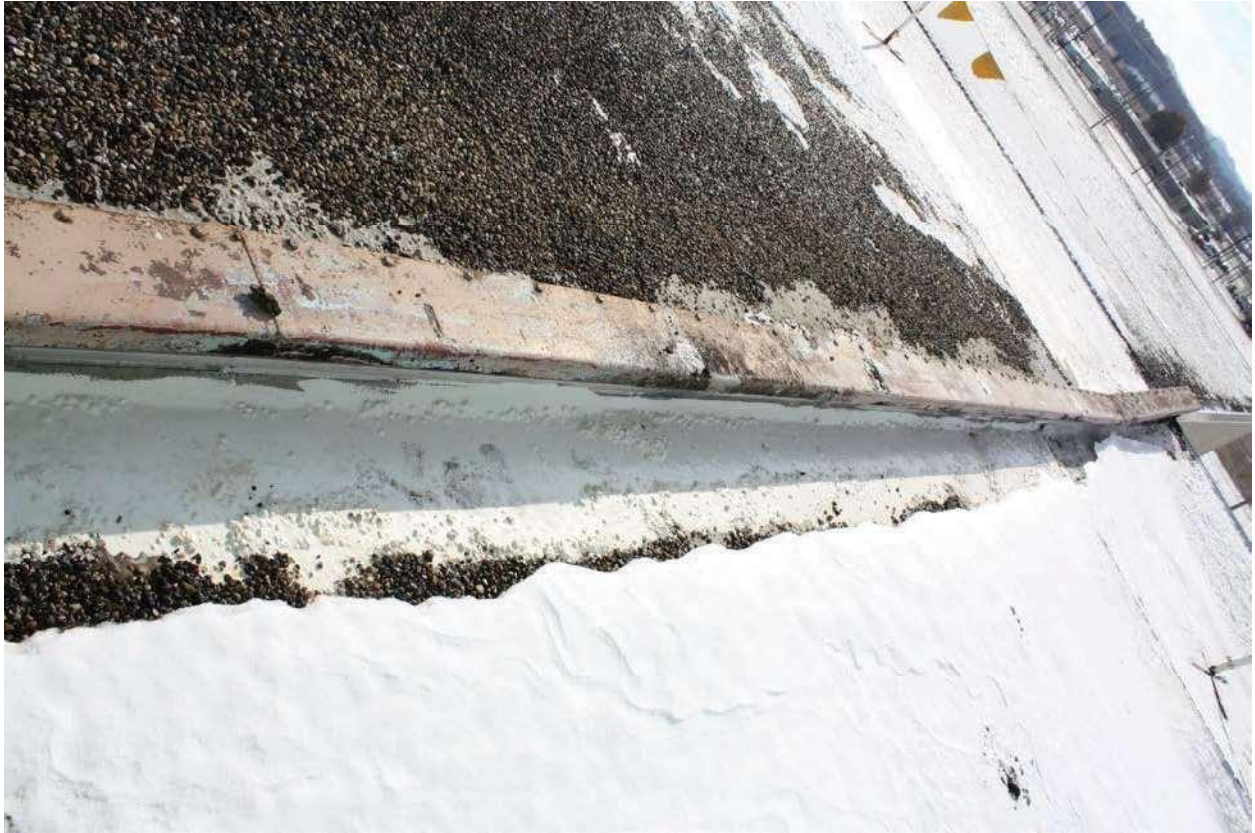
Past Repair of Expansion Joint on Highbay Roof

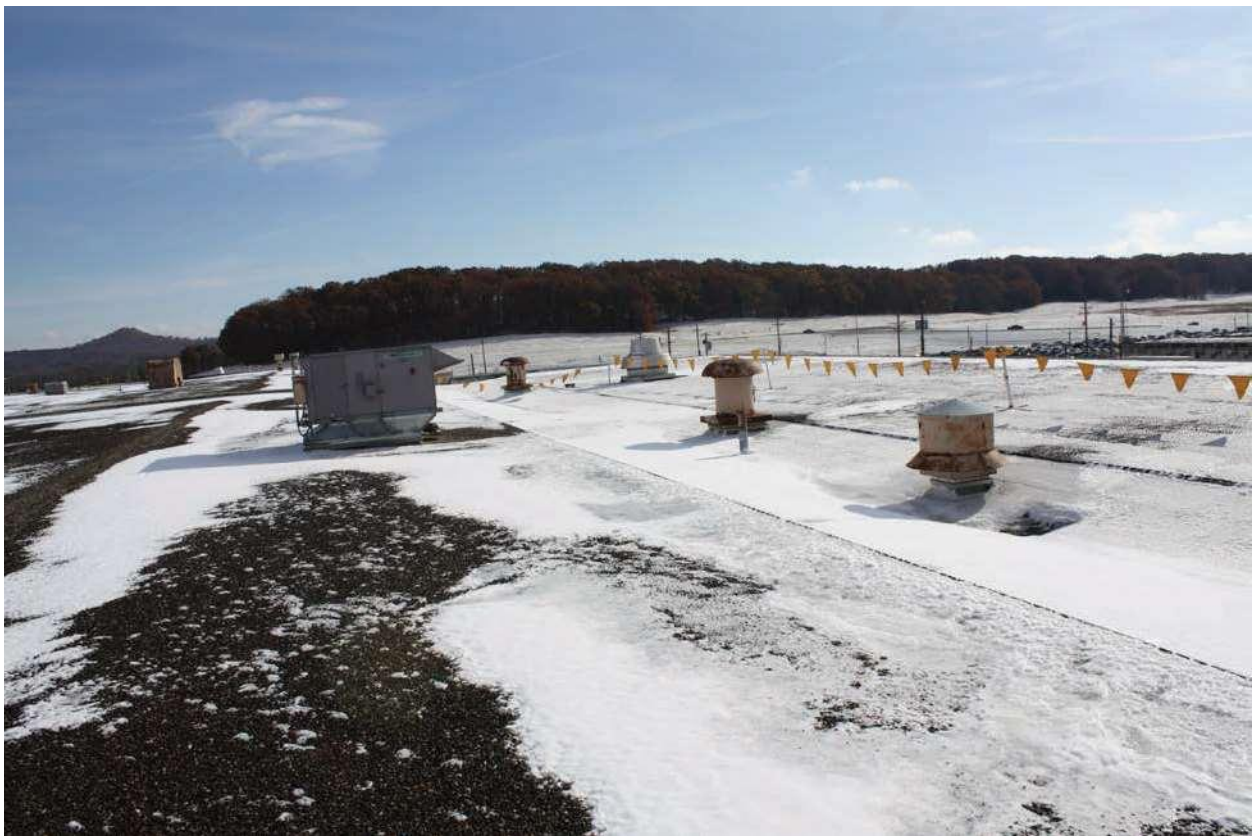
Looking East at TPO Repair of Valley

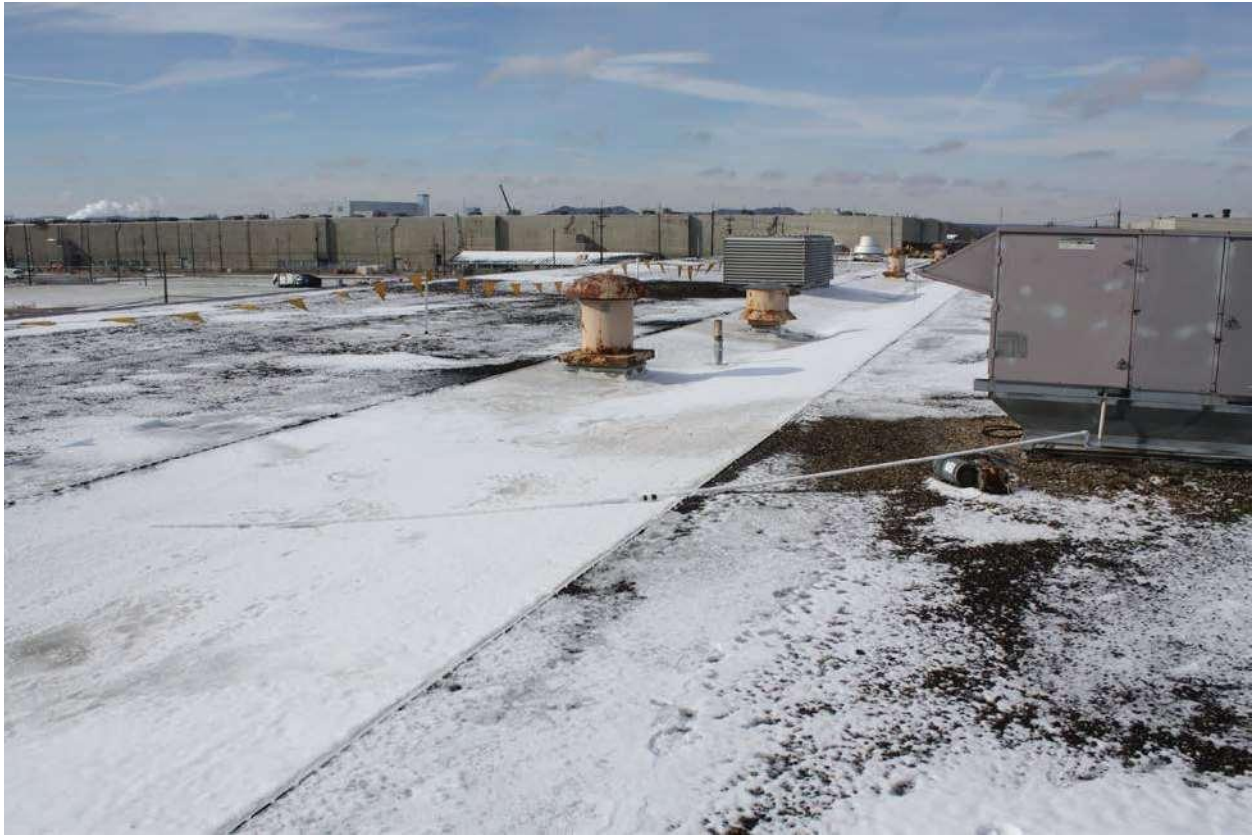
Looking East at TPO Repair of Valley

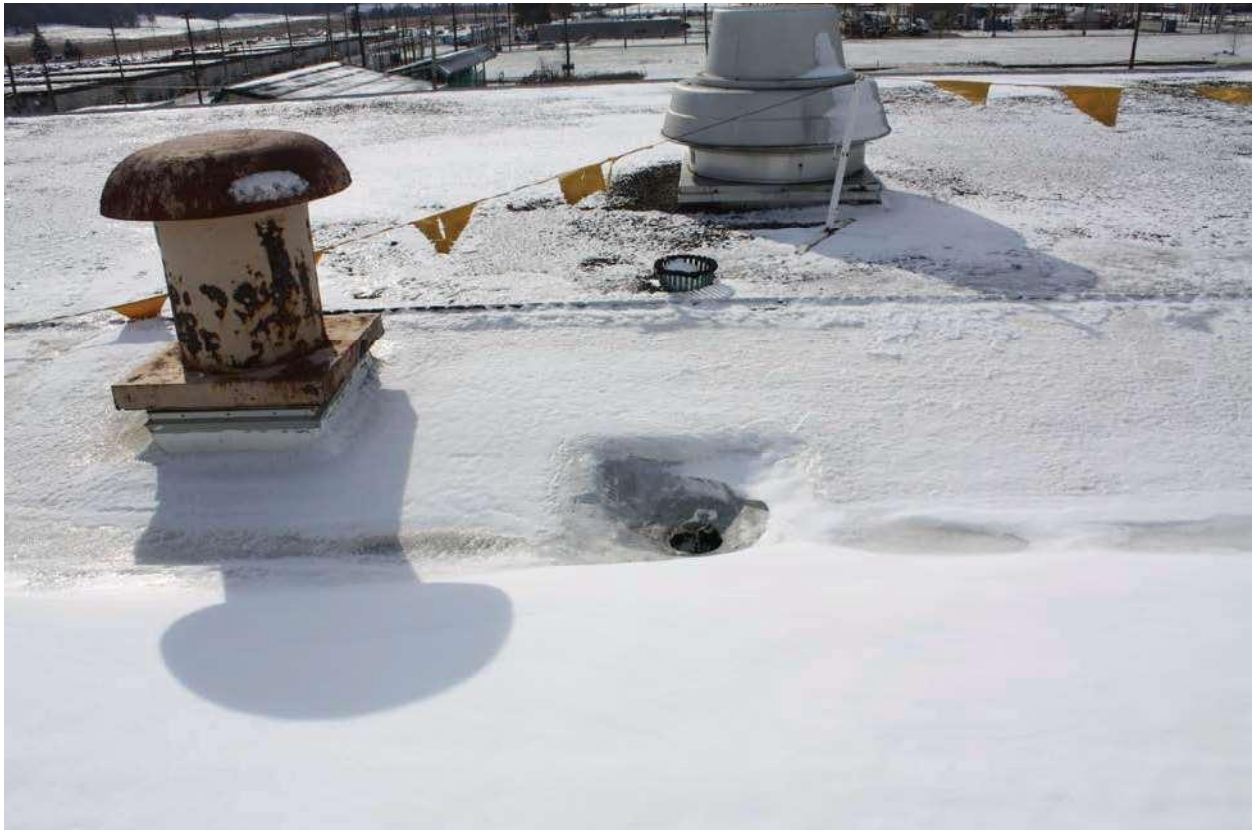
Looking South – Roof Drain Screen to be Replaced on Highbay Roof
