## ENGINEERING EVALUATION COVERSHEET

**Number:** EVAL-DE-2020-0009

**Title:** X-720 Roof Inspection

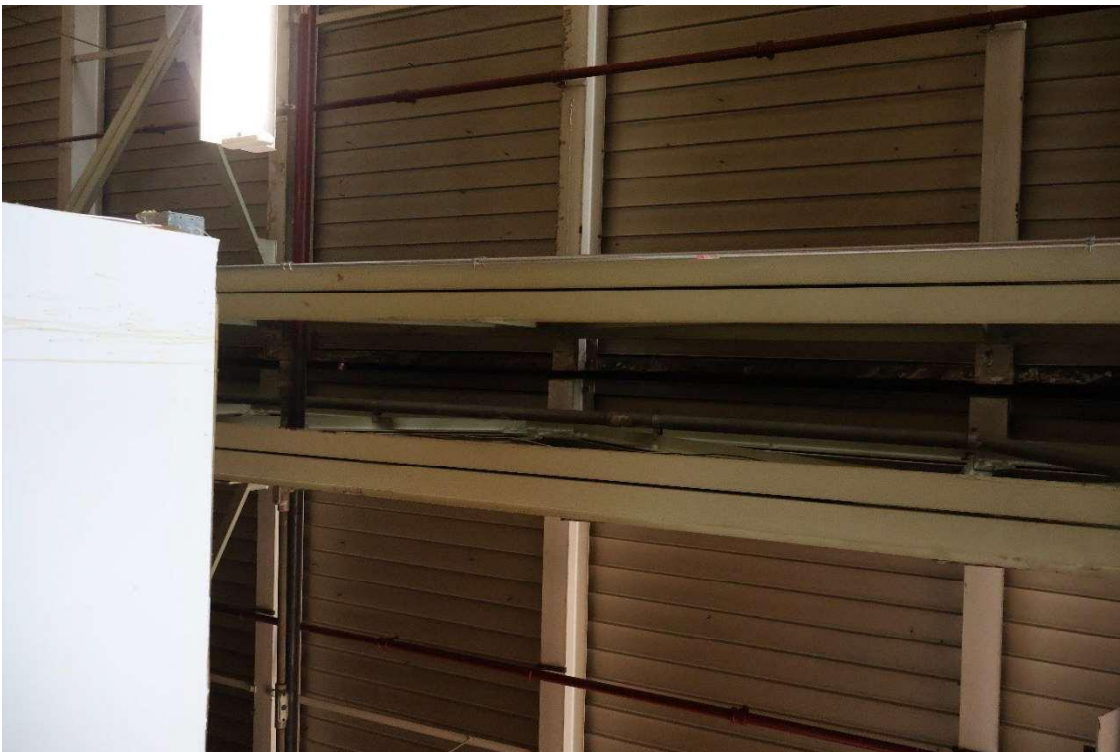
Leak near column C14

Roof above previous picture, near column C14
